COFFELT FARM LEASE RATE AND RESERVE STUDY

Relevant to 150 acres of the 189-acre Coffelt Farm Preserve
1071 Crow Valley Road
Eastsound, WA 98245
FCS File Number: 2021-036 REV

October 19, 2021

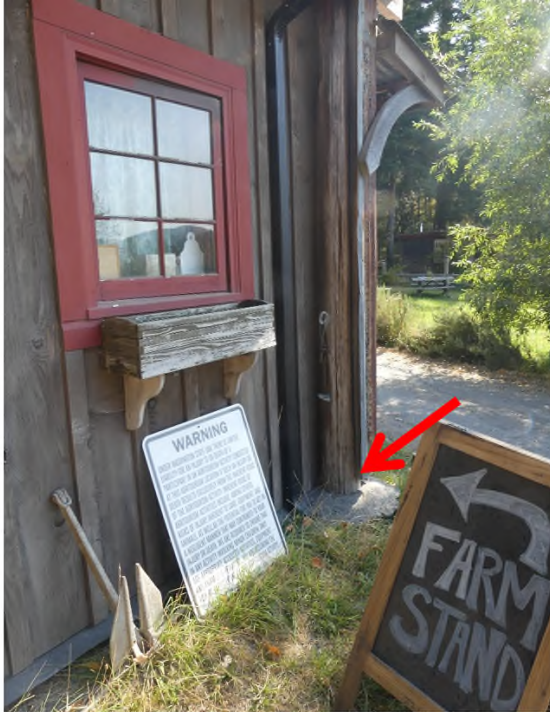
This is an older building, built as a pole barn. As such, the structural columns of the building are partly below the grade of existing soil which can be conducive to decay. Some decay is in evidence in one of the wood columns on the south side near the grade of soil. There is also apparent decay of the wood horizontal nailer board along the bottom of the north wall. There is soil in contact with these boards on the north and west sides, which can be conducive to decay. There is evidence of boring insect (Anobiid beetle) damage to some of the structural timbers of this building. The expectation is that the building, as currently configured, would last more than 10 years. However, substantial capital investment may be required beyond the 10-year study period to maintain the structure.

Decay in bottom of structural column below grade

- Add fascia boards and gutters to north side to control roof drainage
- Maintain roofs & gutters to ensure proper function of roof drainage.
- Consider further evaluation of damaged siding nailer boards at bottoms of north and west walls. Improve grading to eliminate soil contact and/or replace nailer boards with pressure treated material.

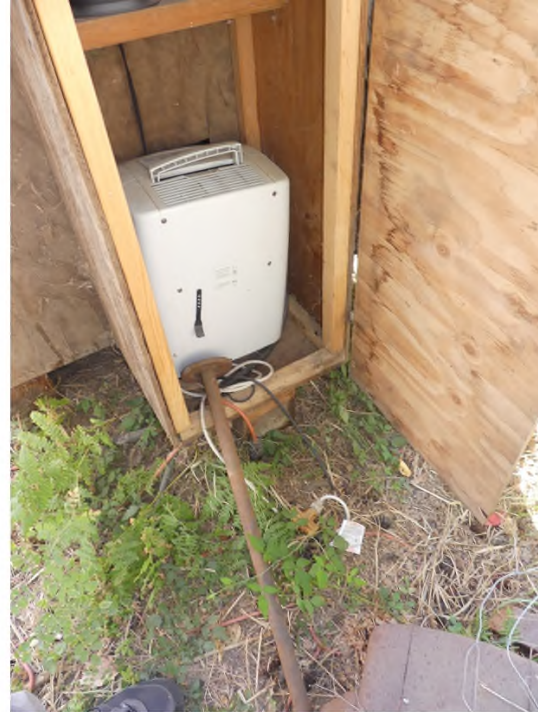
Extension cord run to outside shed

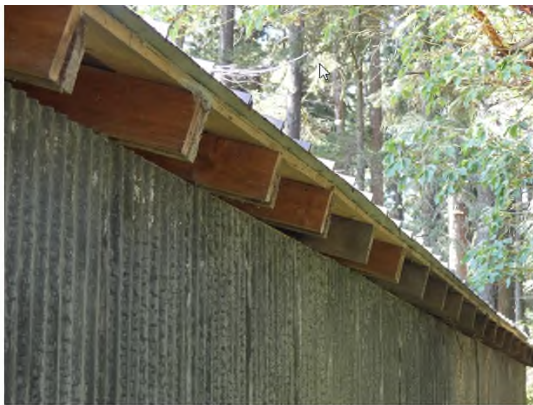
No fascia board or gutter on north side

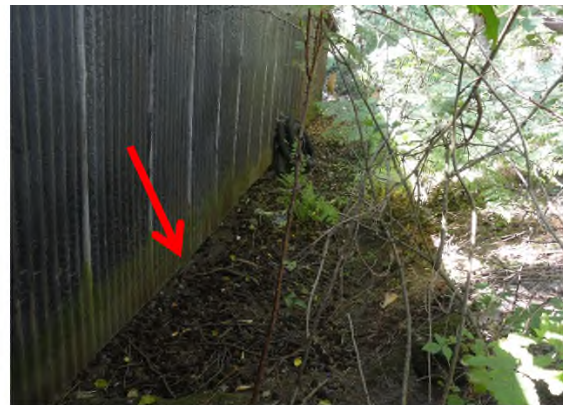
decay in siding nailer, Soil contact along bottom of north wall

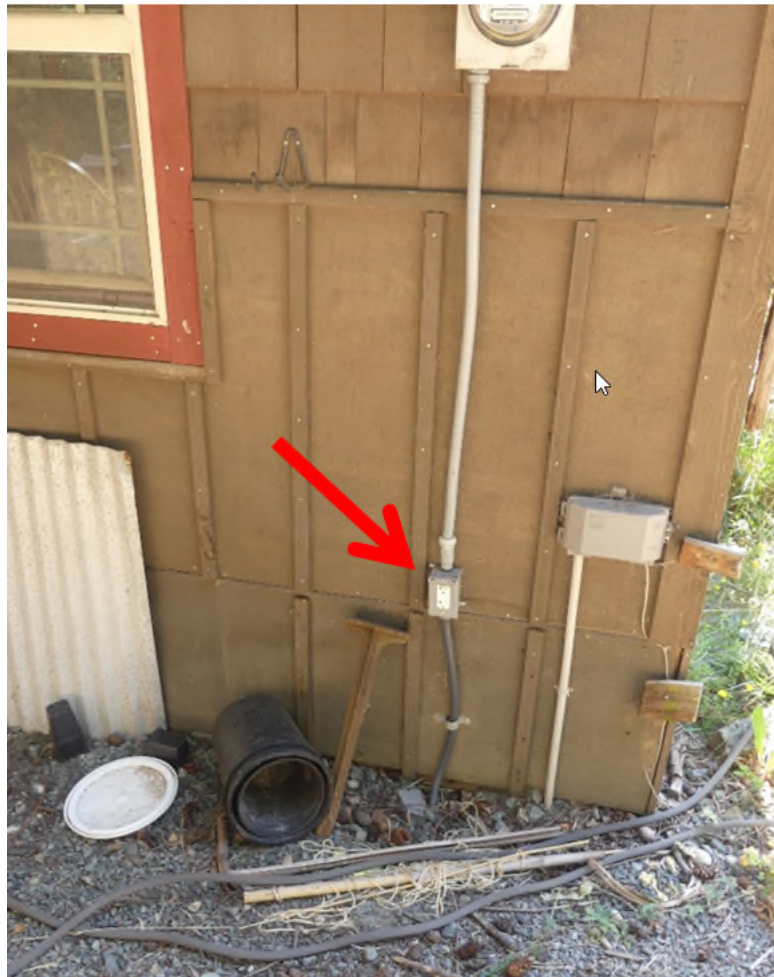
exterior receptacle has "Open ground"

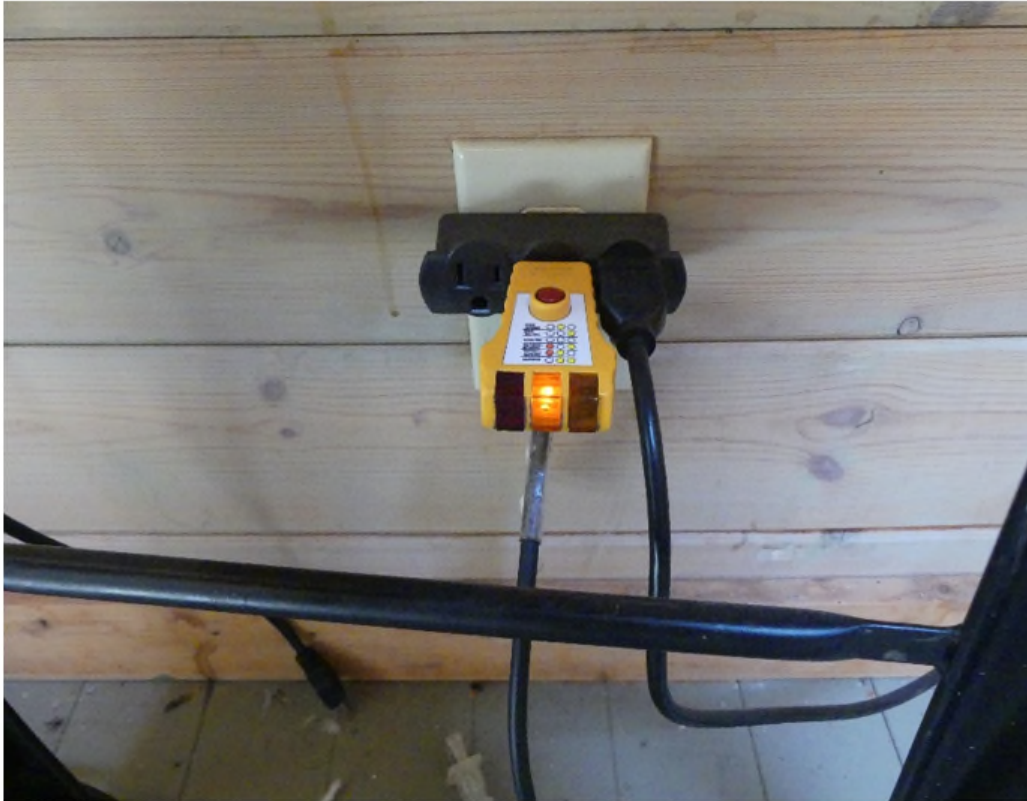
interior receptacle has "Open ground"

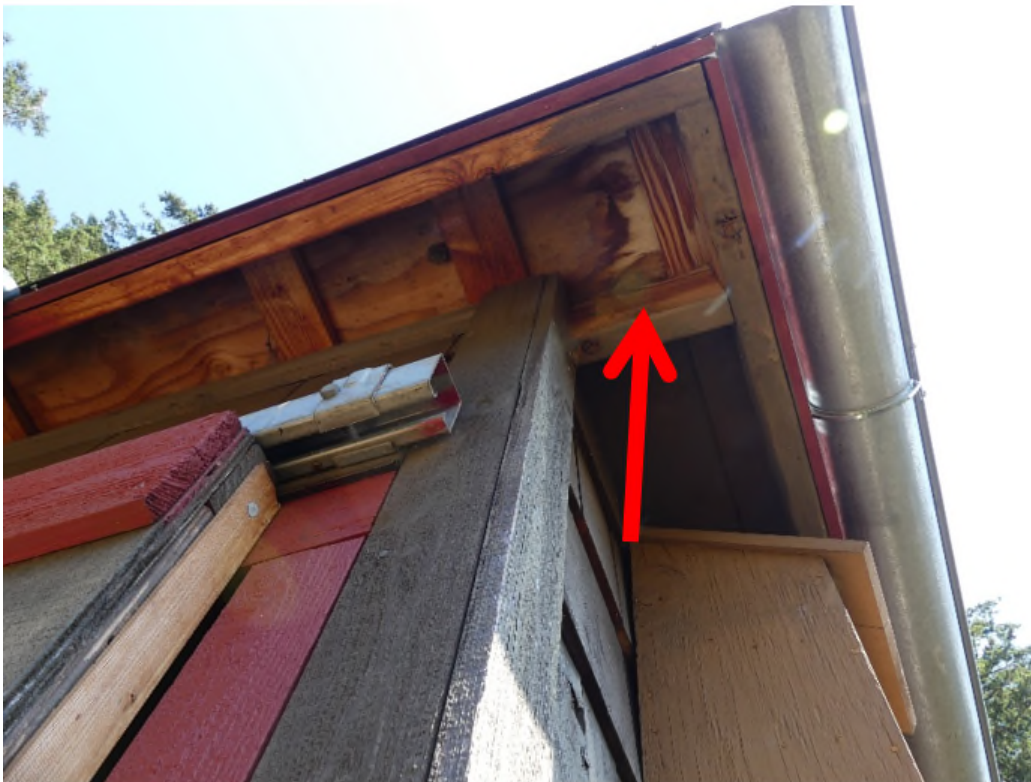
The office building has had some fairly recent renovation, including newer standing seam metal roofing, combination of plywood and wood shingle siding which is in good condition, and metal gutters & downspouts. There is staining in the roof plywood visible at the eave at the west side of the southeast shed of the office building; it is unclear if there is ongoing leaking, periodic problems such as gutter overflowing when blocked with debris, or a prior leak that was repaired.

Staining in eaves at roof corner

- Monitor area of staining in eaves for indications of active leaking.
- Monitor and maintain roofs & gutters to ensure proper function of roof drainage.
- Clean wood stove & chimney pipe annually and electric wall heater twice annually.

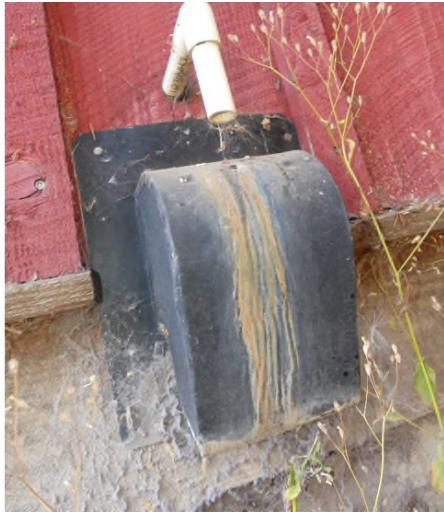
Evidence of discharge from boiler

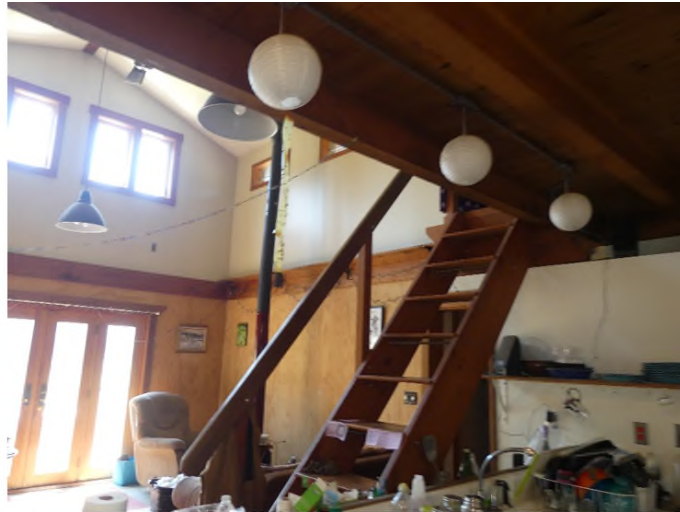
loft stairs

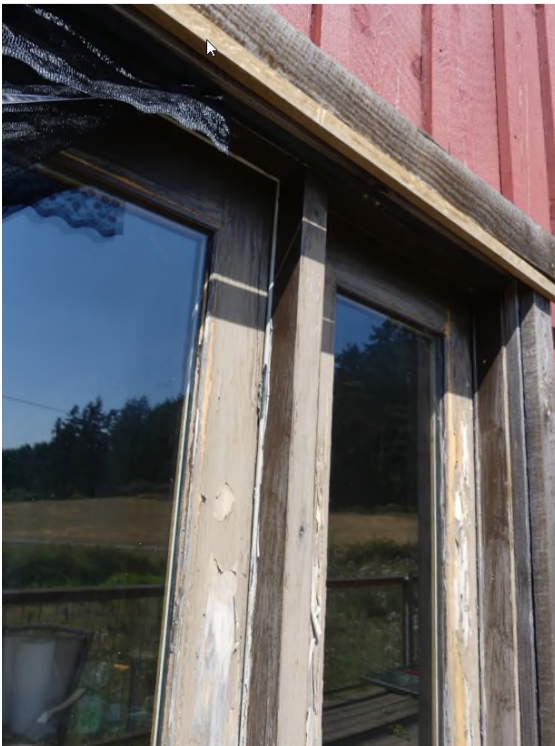
Deteriorating exterior finish on French door

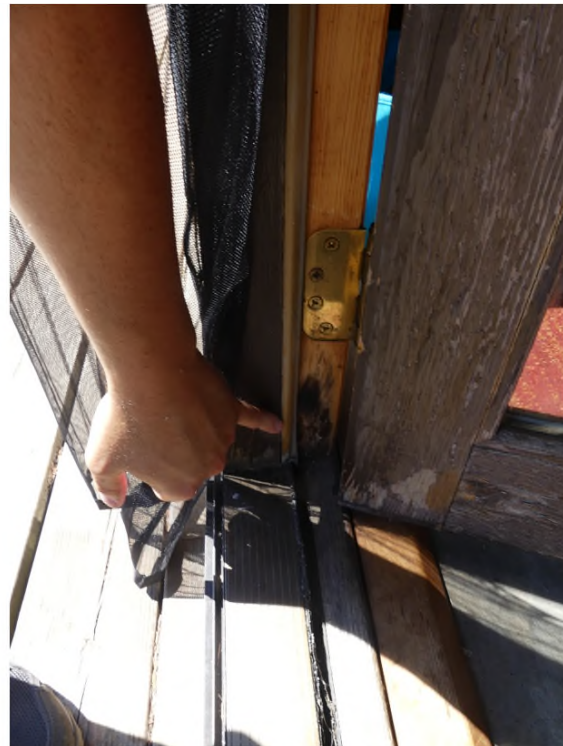
Decay in bottom of door jamb

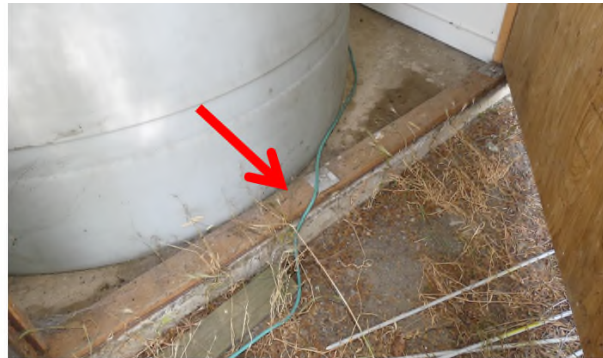
extension cord is pinched by door

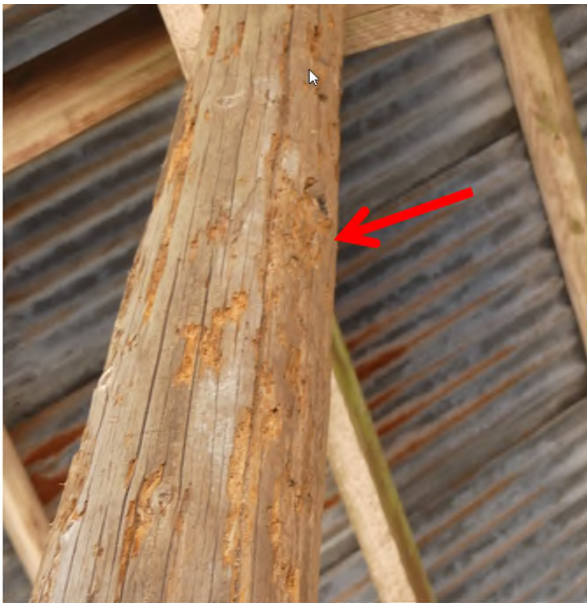
The wood columns appear to be creosoted at their bottoms where in contact with grade. There appears to be some decay / deterioration in the upper portions of some of these columns. The building is in generally good condition, typical of smaller barns of this age.

deterioration in wood pole at NW corner

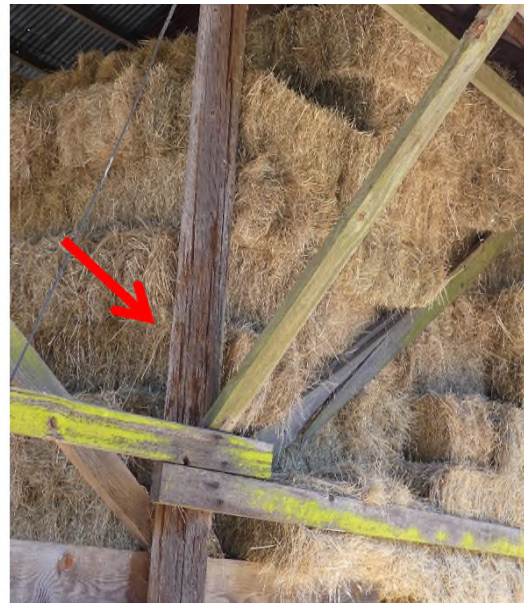
deterioration in wood poles at middle of south side

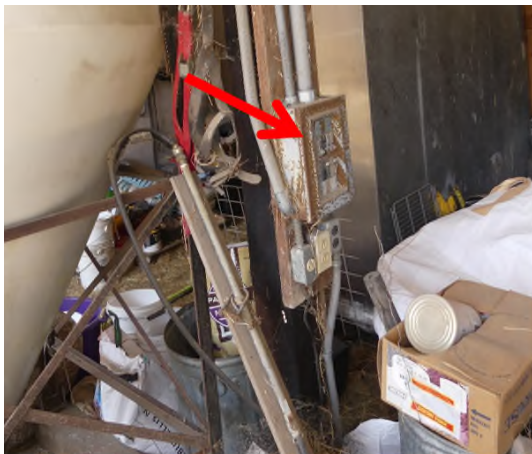
Older electrical sub-panel in east bay

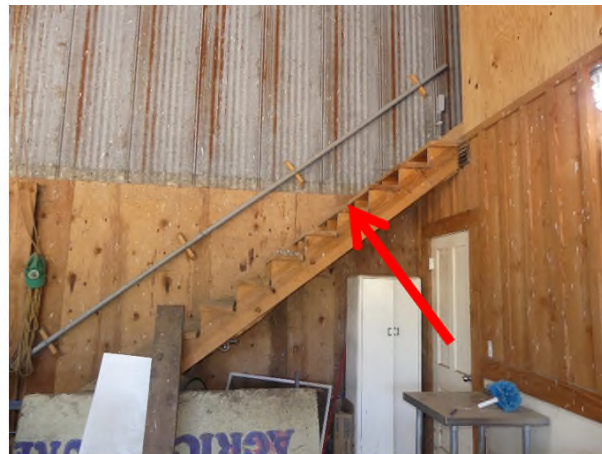
no railing on open side of stairs to tack room

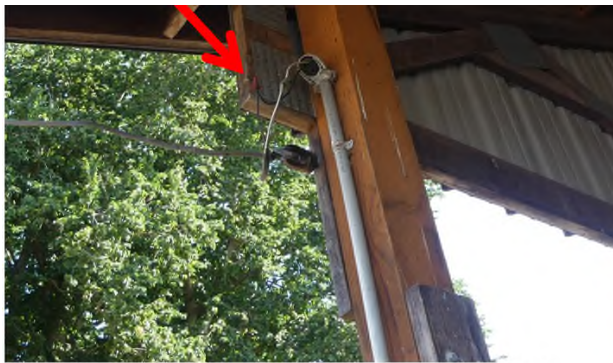
Wiring splice at electrical drop not in box

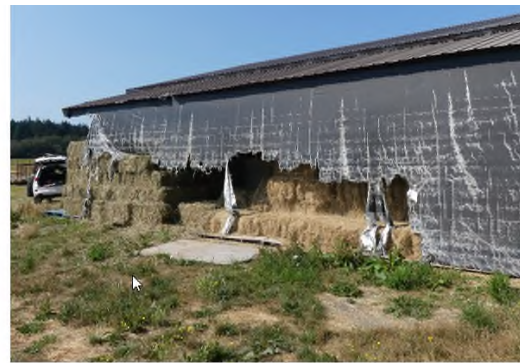
tarp in poor condition

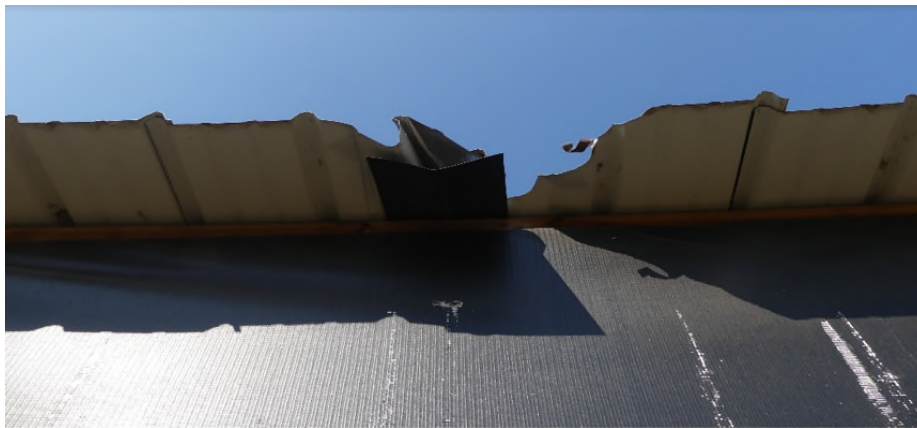
roof damage

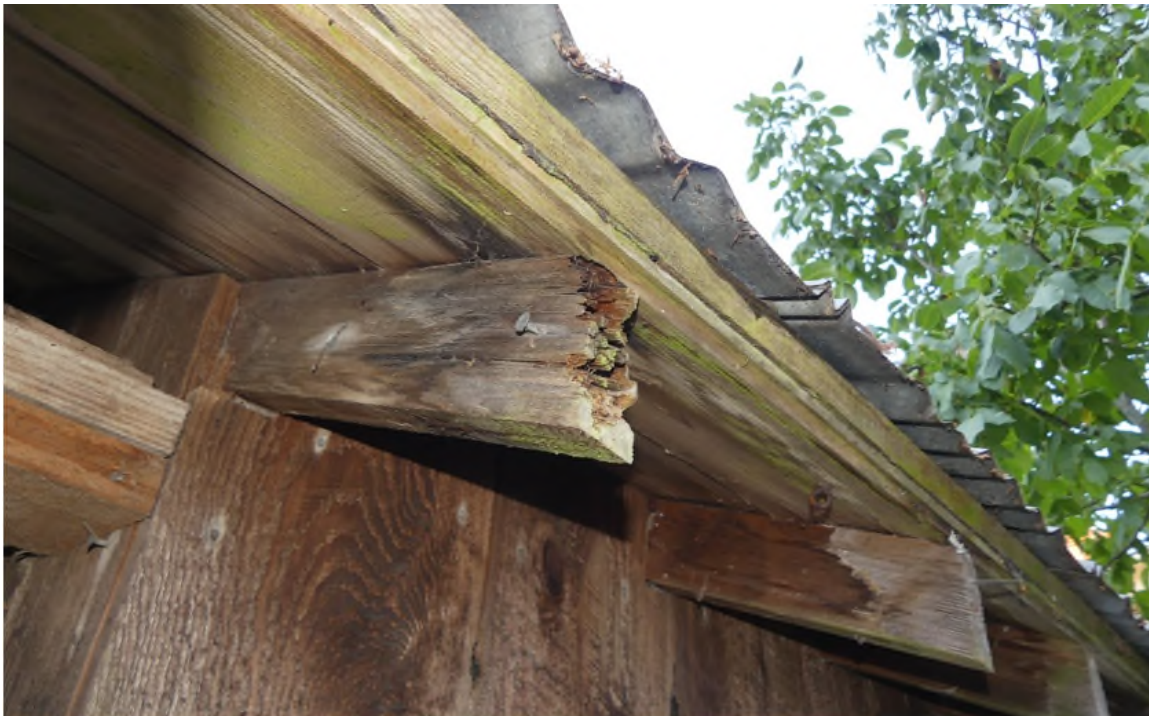
Water damage in rafter tails of storage building

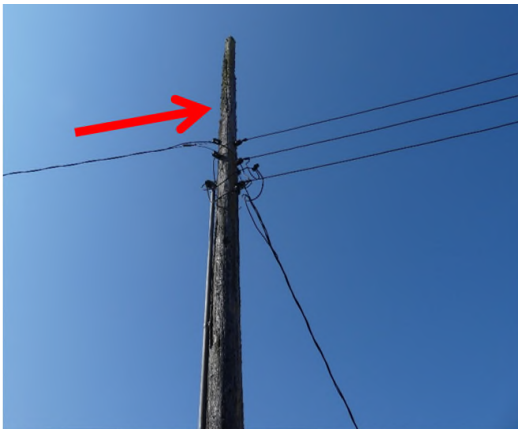
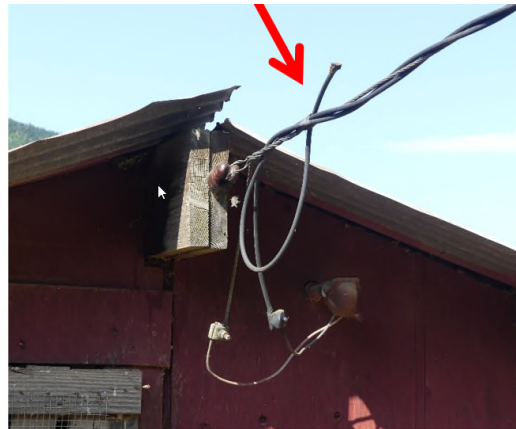
Wood utility pole showing deterioration near top **Unused energized conductor only capped with tape**

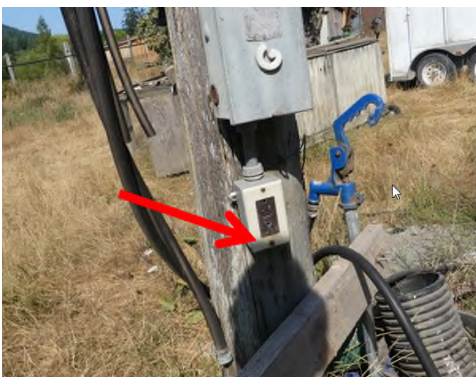
GFCI receptacle did not trip when tested

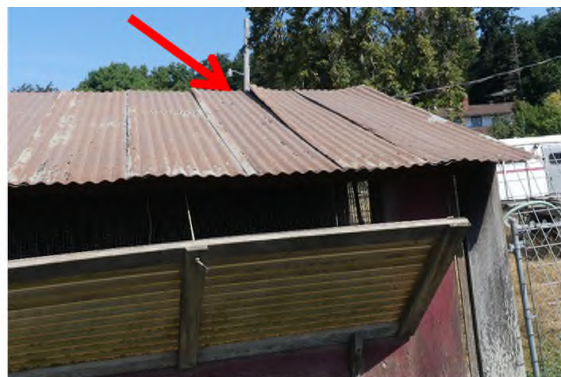
roof panels appear to need minor repairs

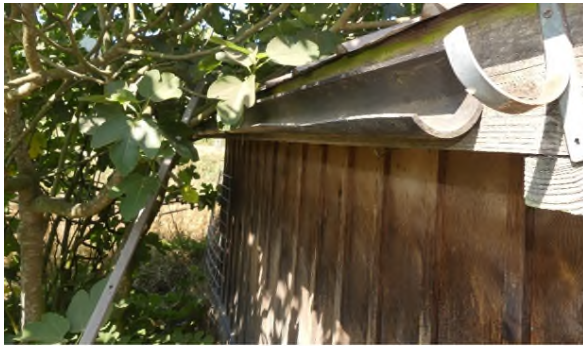
Tree in contact with gutter

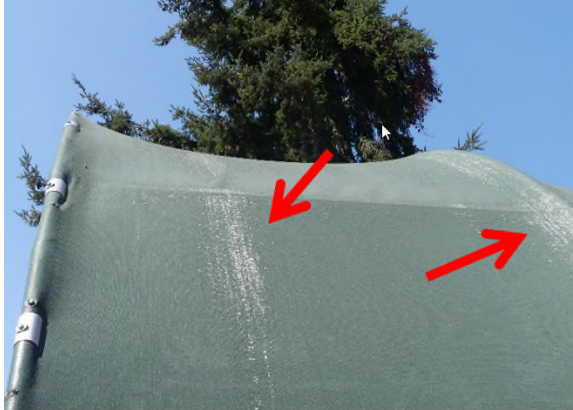
This is an industrial metal hoop storage structure with poly tarp sheeting. The metal frame is in good condition, the tarp sheeting is showing early signs of deterioration and will likely require replacement in the near future.

Tarp beginning to deteriorate

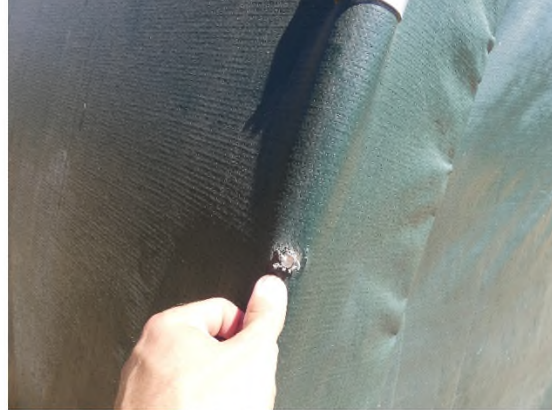
Small hole in tarp
