AGENDA
San Juan County Conservation Land Bank Commission

STEWARDSHIP & OUTREACH REPORT
SEPTEMBER 2024

CRITICAL AREAS ASSESSMENT & MITIGATION PLAN **(WETLAND DELINEATION & FWHCA ASSESSMENT)**

BAILER HILL / DOUGLAS ROAD
ROAD IMPROVEMENTS PROJECT
SAN JUAN ISLAND, WA

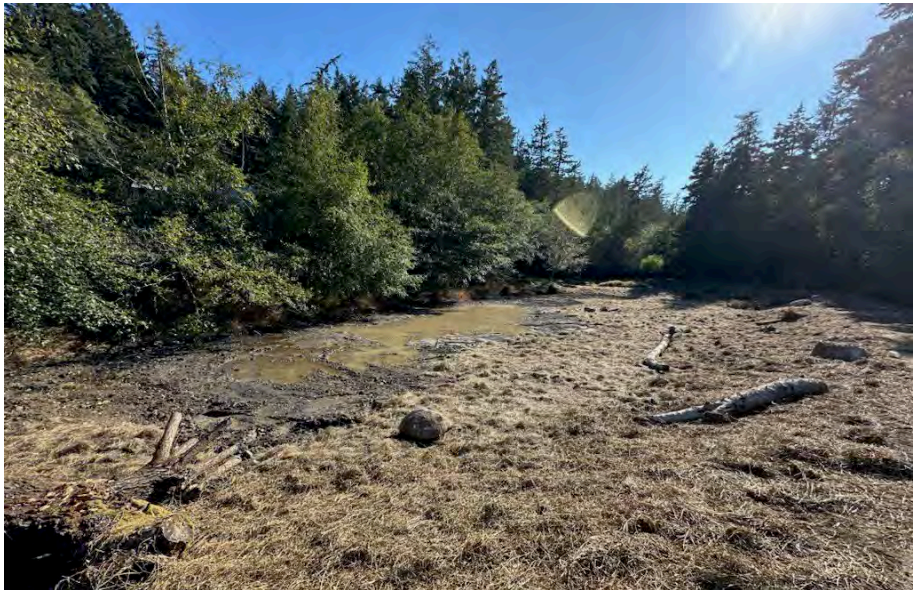
Photo 11. Late summer rains partially fill new wetlands at North Shore Preserve.

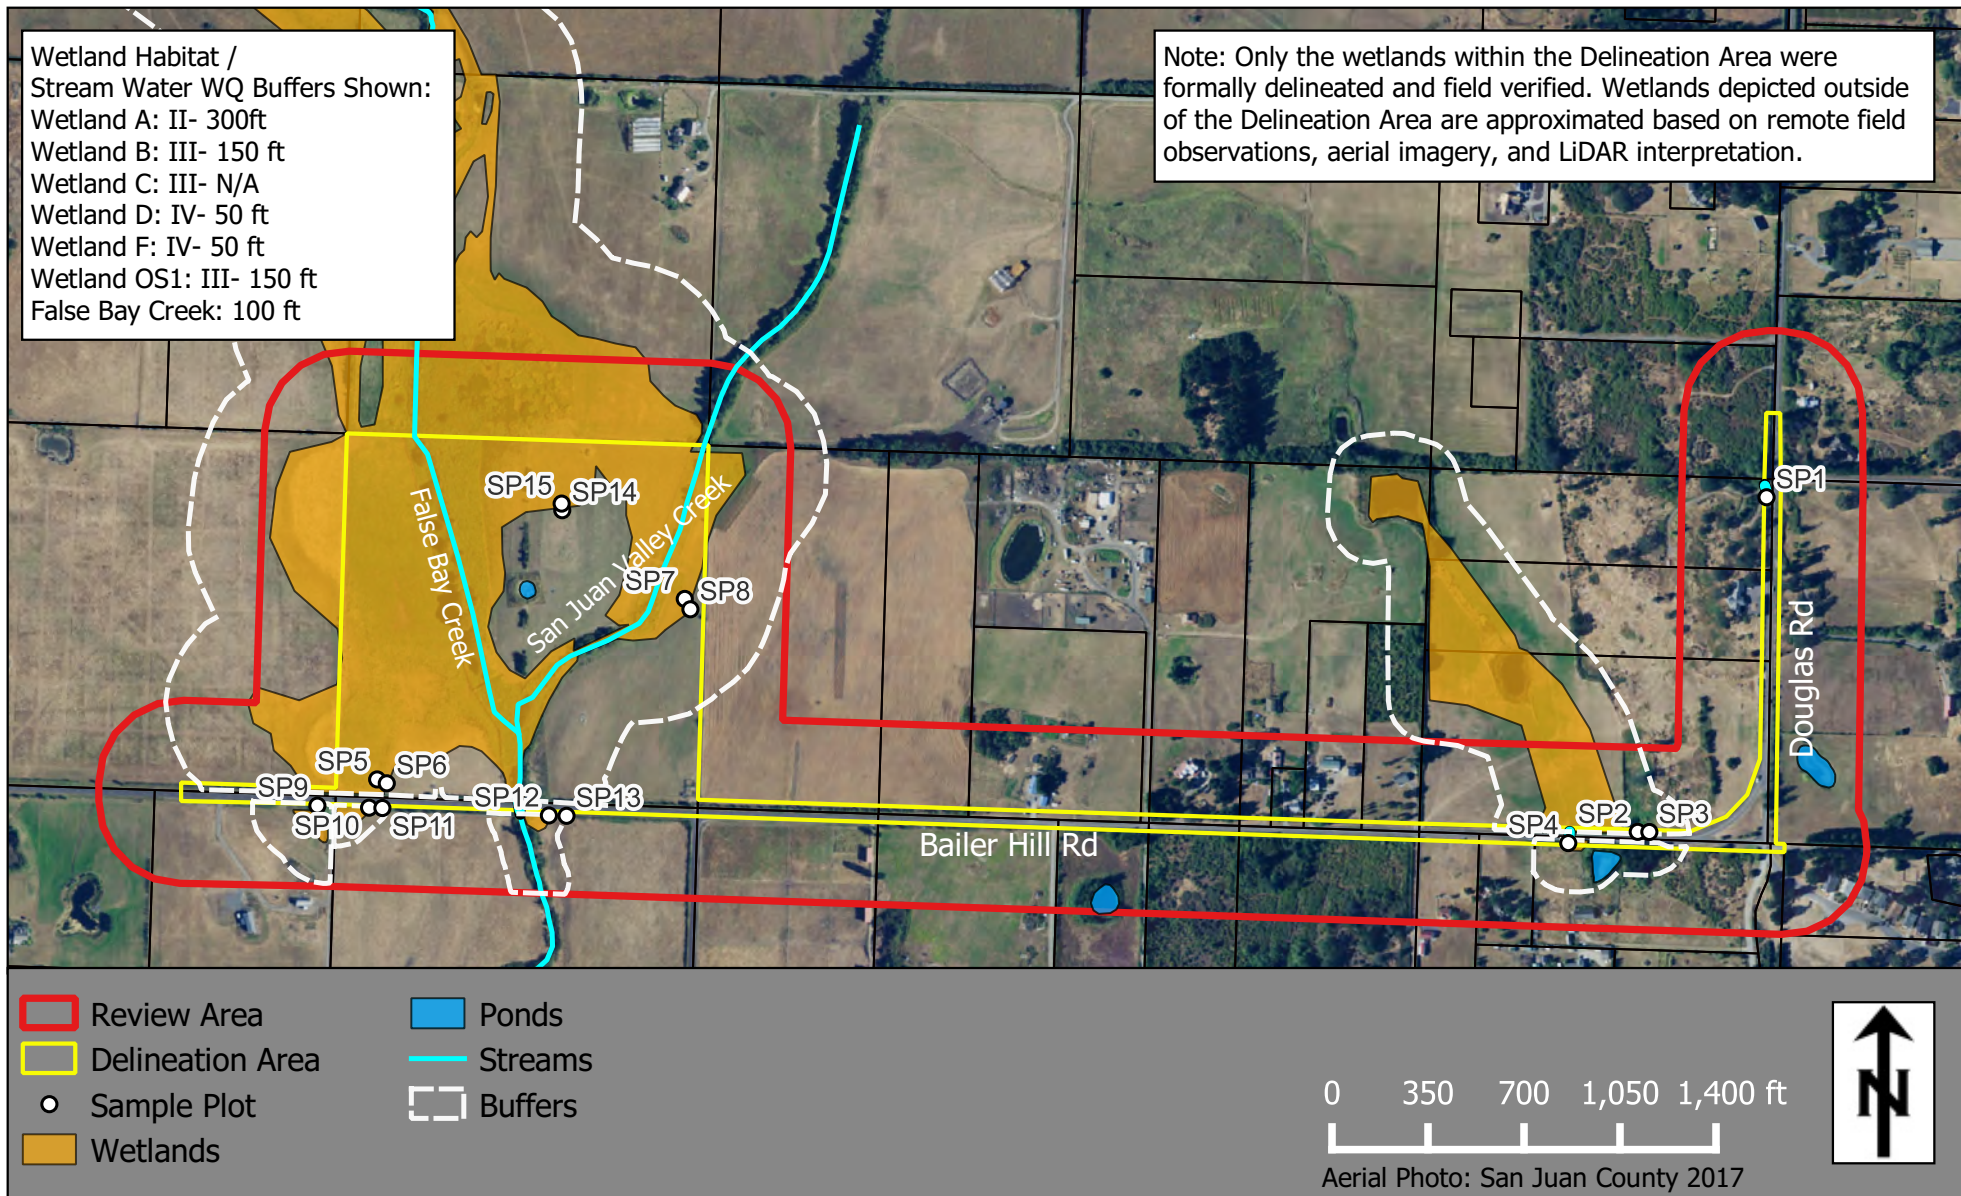
Wetland Map (Overview)	Figure 3
	Bailer Hill/Douglas Road Road Improvements Project Critical Areas Assessment & Mitigation Plan	July 2024

Note: Only the wetlands within the Delineation Area were formally delineated and field verified. Wetlands depicted outside of the Delineation Area are approximated based on remote field observations, aerial imagery, and LiDAR interpretation.

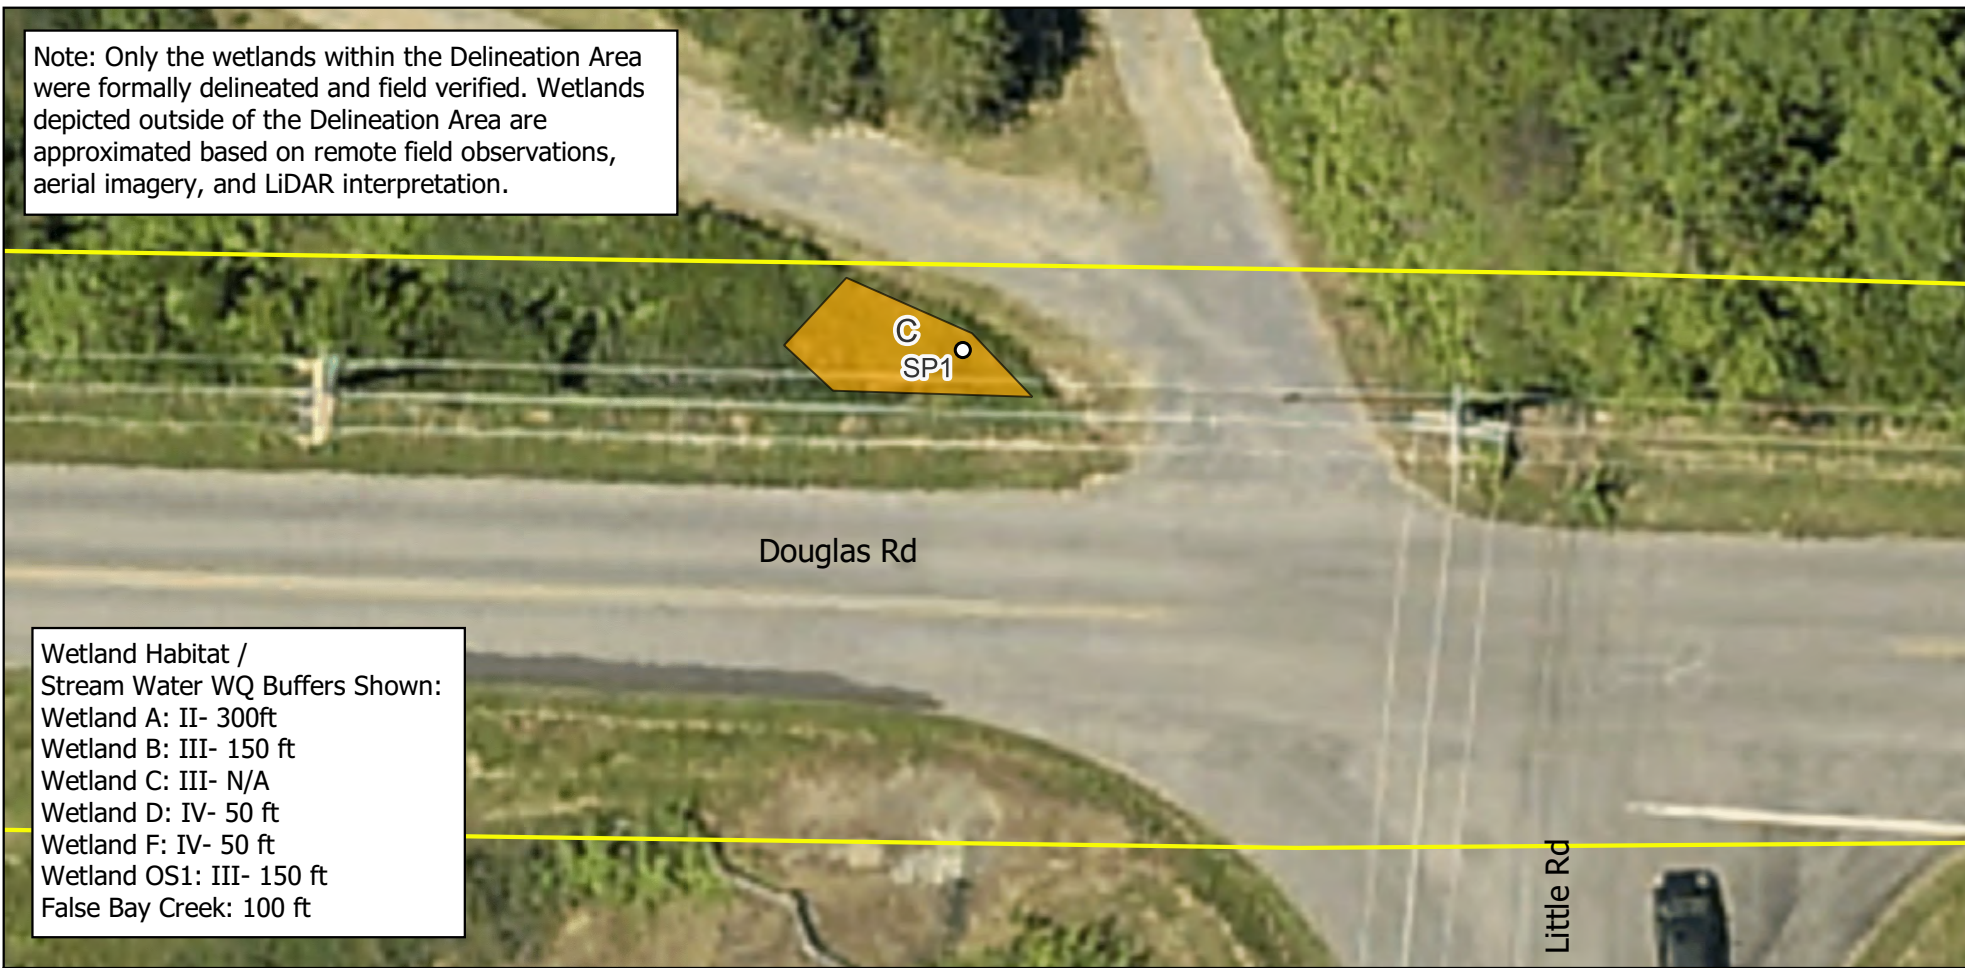
Wetland Habitat /
Stream Water WQ Buffers Shown:
Wetland A: II- 300ft
Wetland B: III- 150 ft
Wetland C: III- N/A
Wetland D: IV- 50 ft
Wetland F: IV- 50 ft
Wetland OS1: III- 150 ft
False Bay Creek: 100 ft

<p>E COLOGICAL</p> <p>NORTHWEST</p>	<p>Wetland Map (Northern Extent)</p> <p>Bailer Hill/Douglas Road Road Improvements Project Critical Areas Assessment & Mitigation Plan</p>	<p>Figure 4</p> <p>July 2024</p>
--	---	--

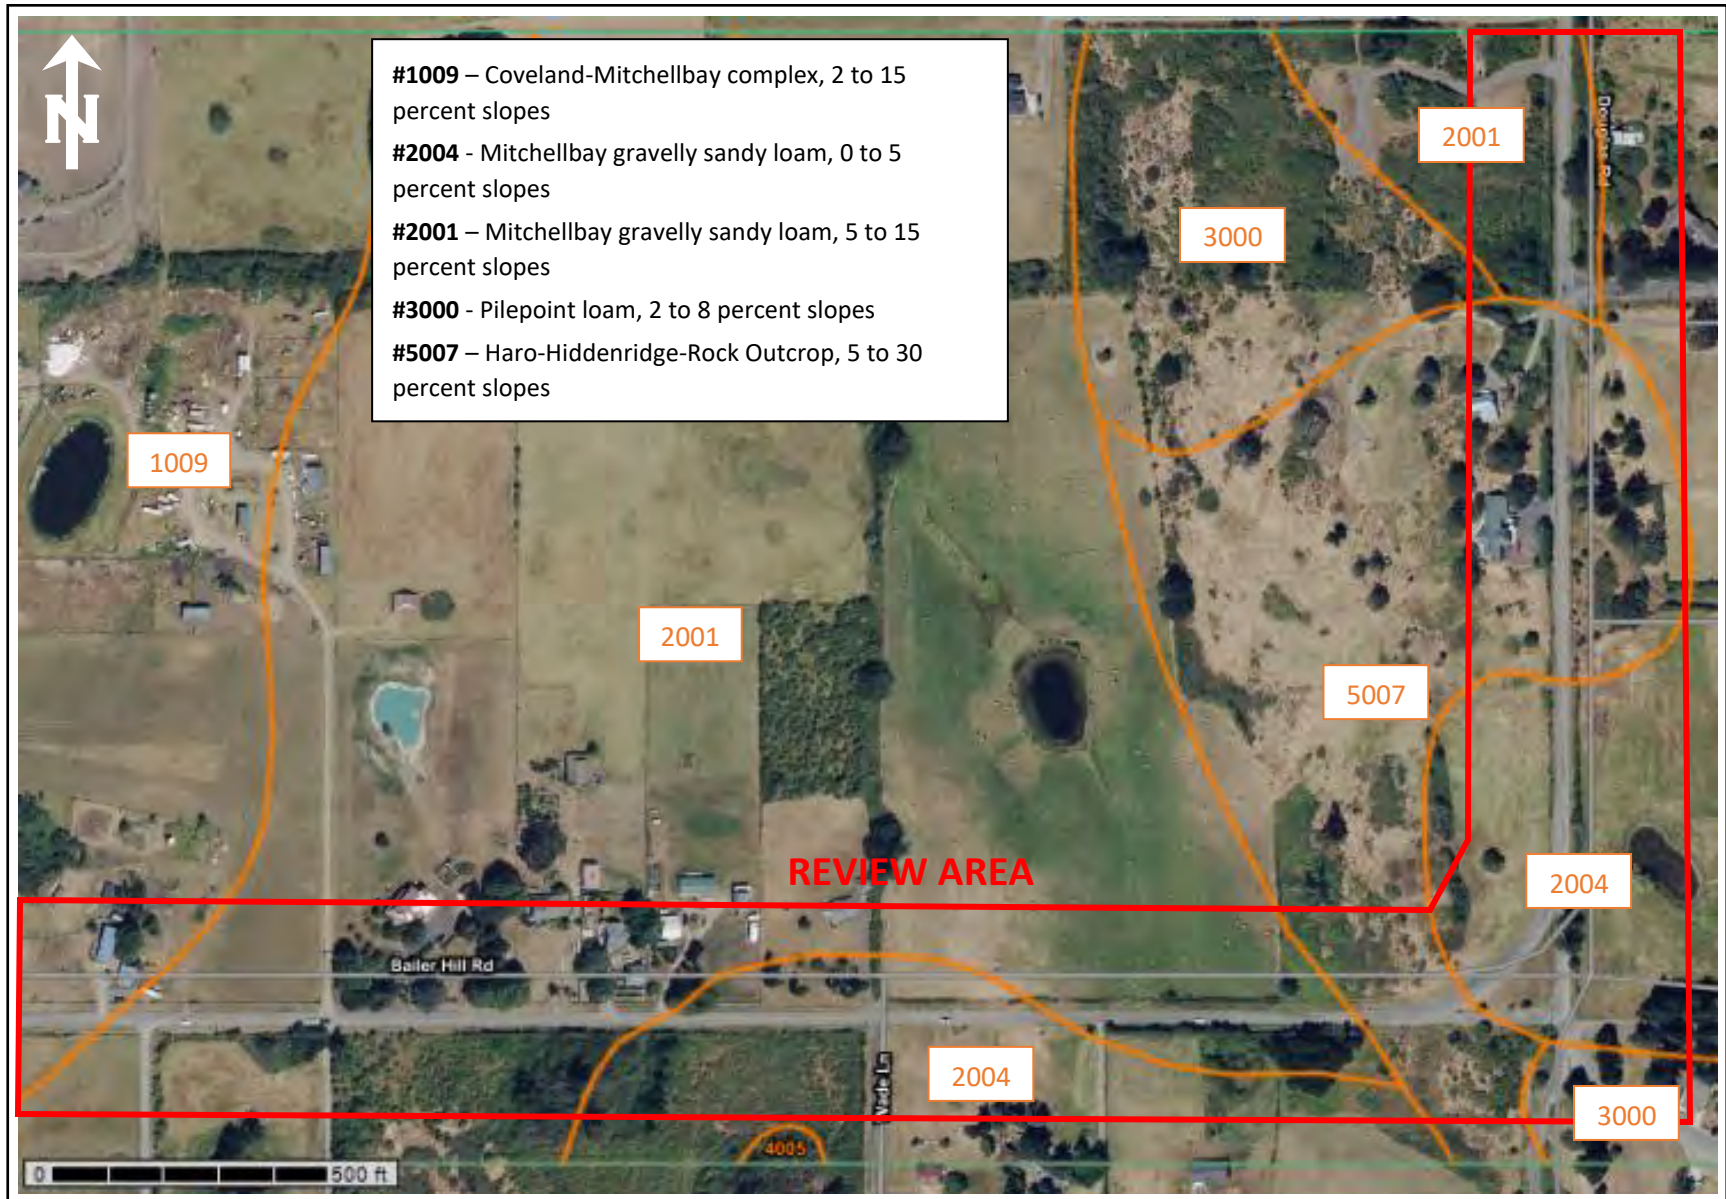
<p>Soil Map – Eastern Review Area (NRCS Soil Survey)</p> <p>Bailer Hill/Douglas Road Road Improvements Project Critical Areas Assessment & Mitigation Plan</p>	<p>Figure 8</p> <p>July 2024</p>
---	---	---

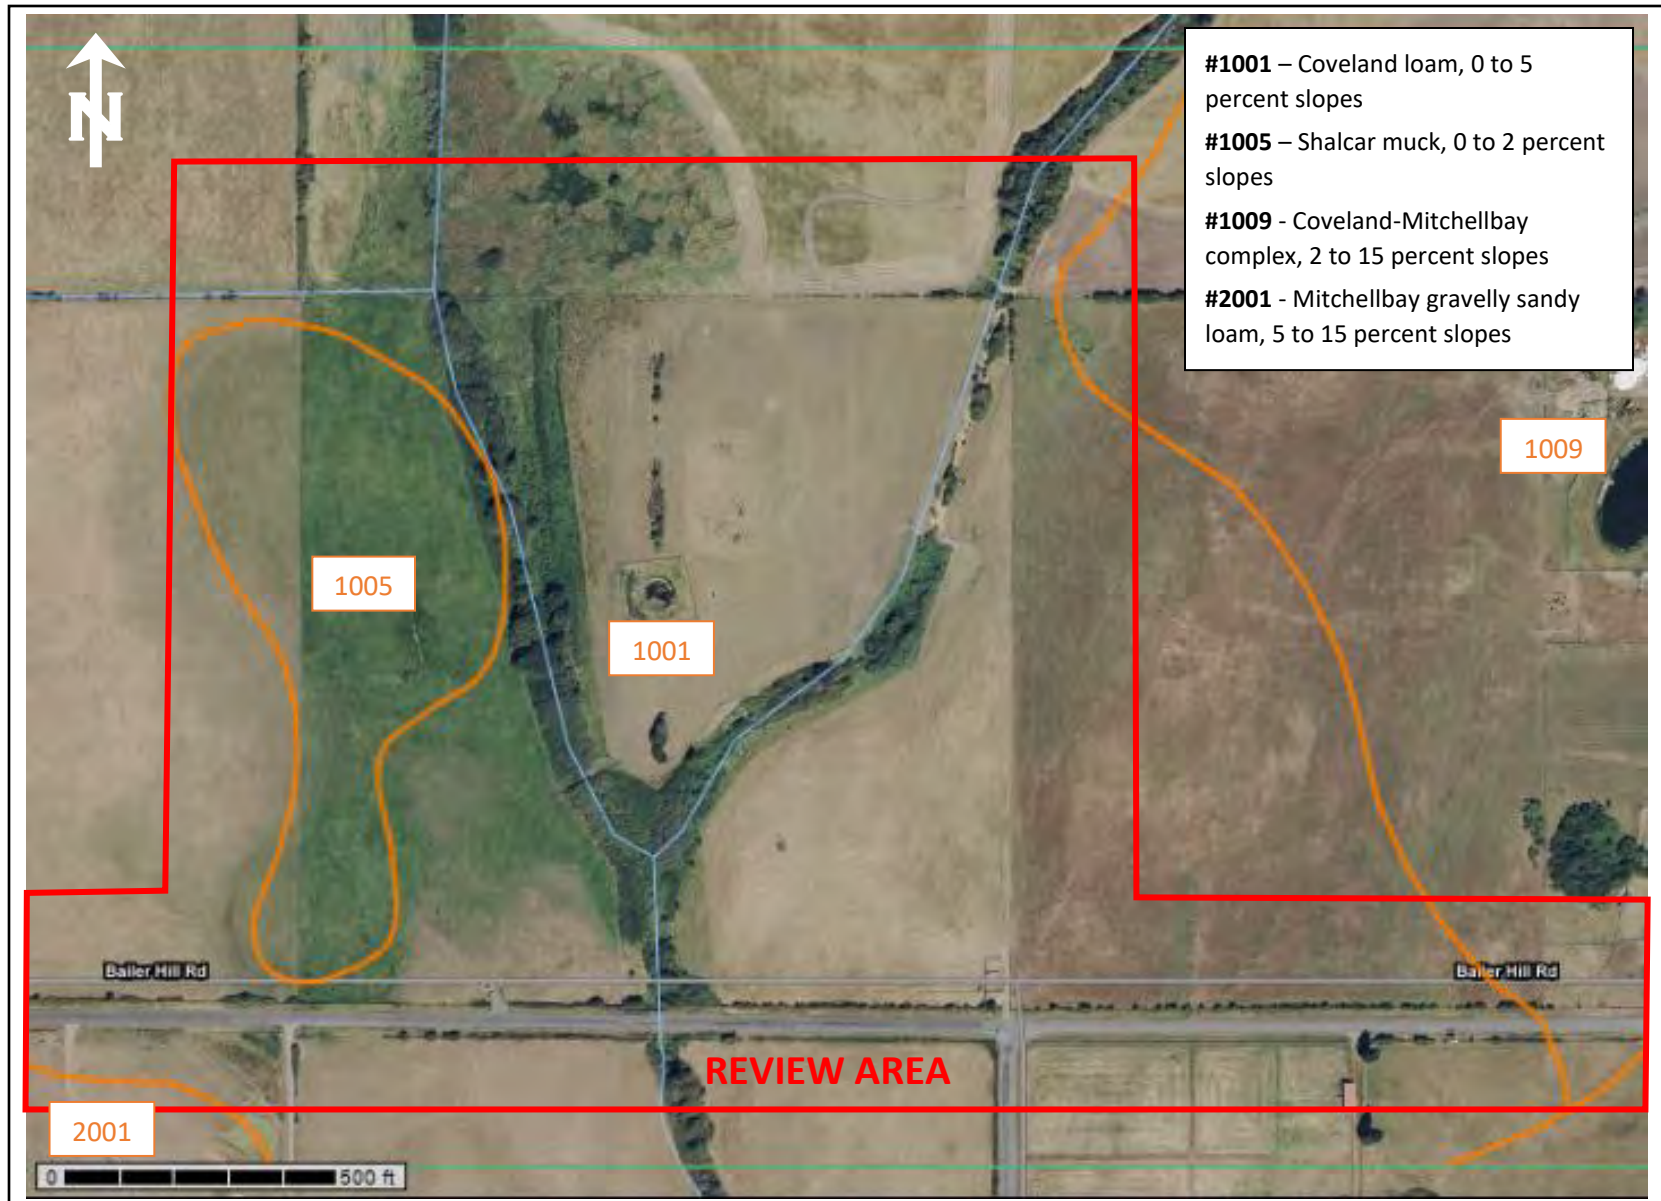
<p>Soil Map – Western Review Area (NRCS Soil Survey)</p> <p>Bailer Hill/Douglas Road Road Improvements Project Critical Areas Assessment & Mitigation Plan</p>	<p>Figure 9</p> <p>July 2024</p>
---	--	--

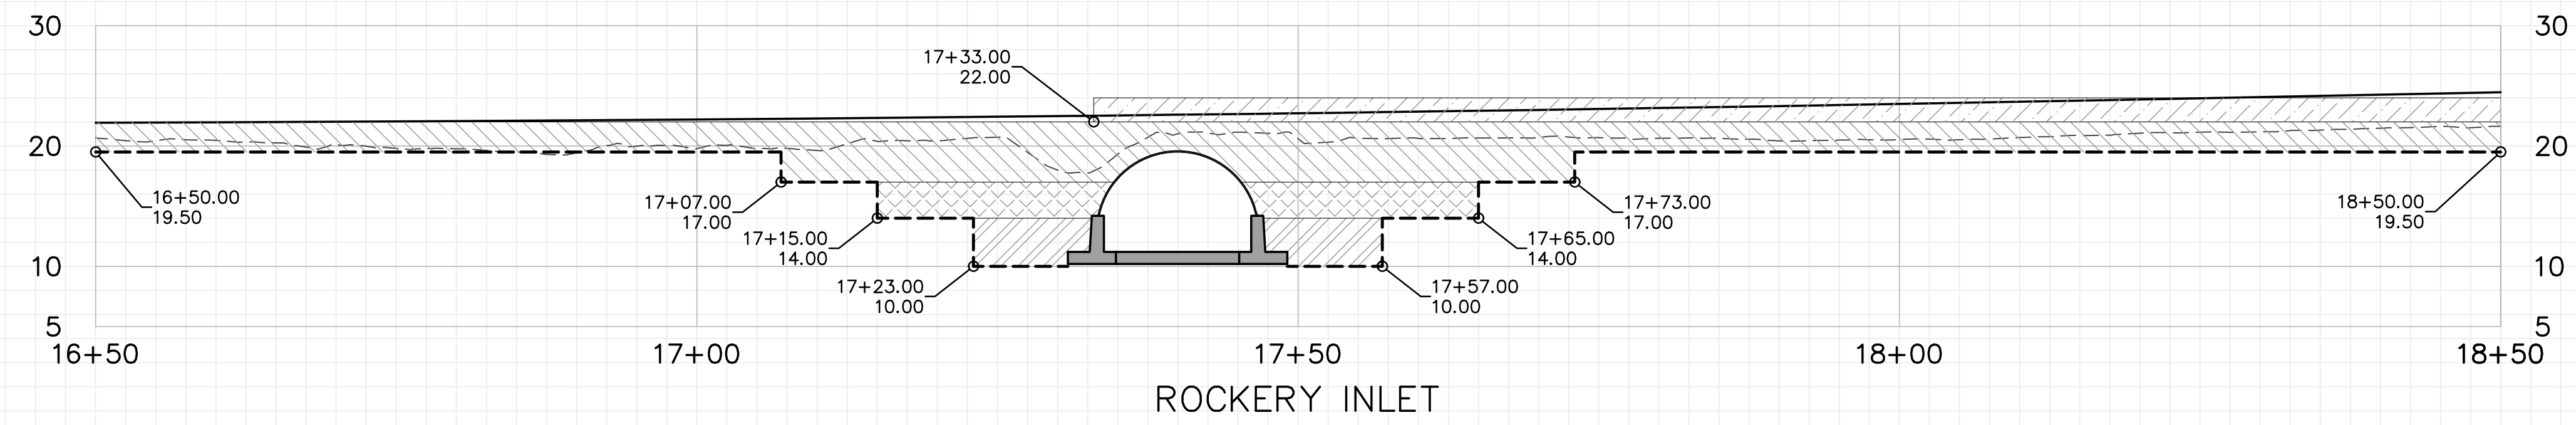
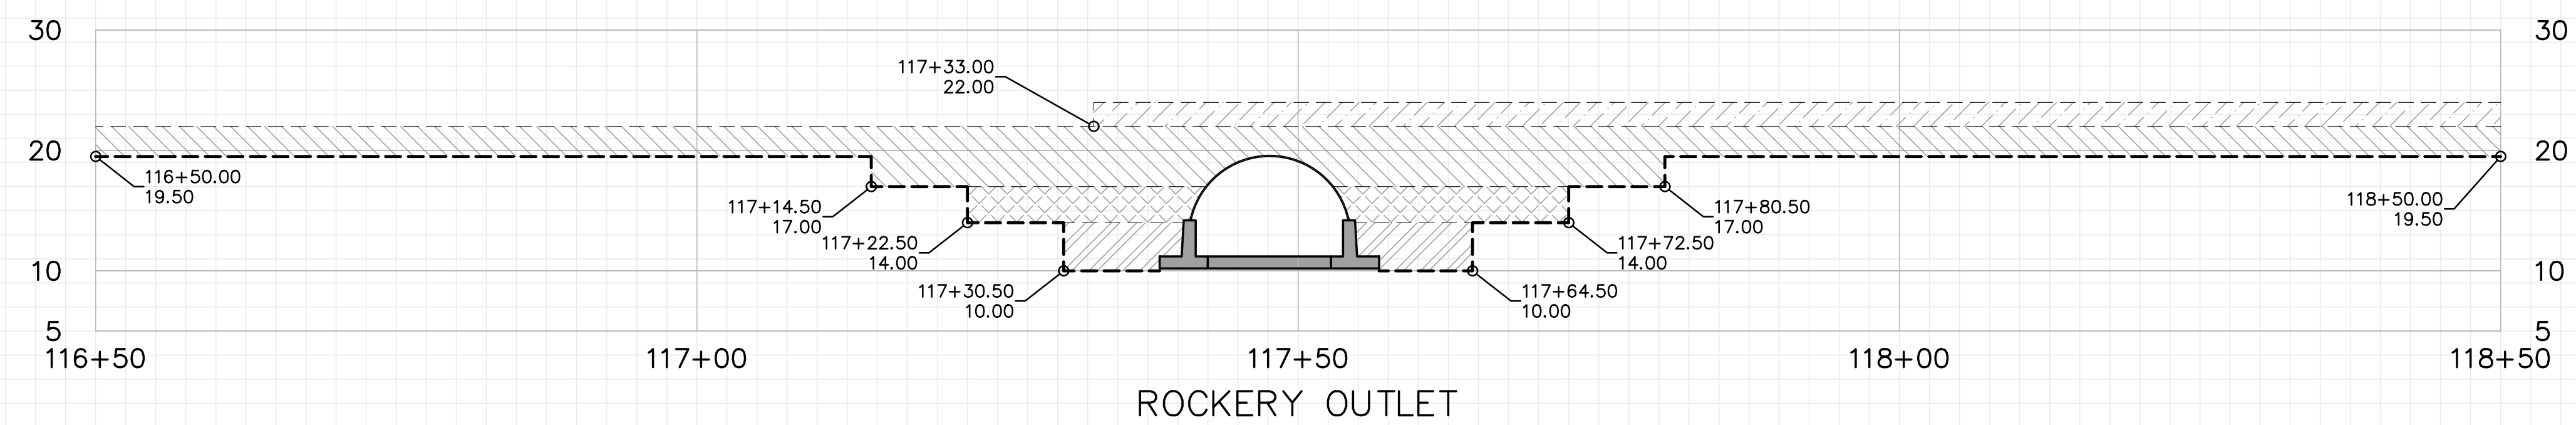
Figure 15

ROCKERY LEGEND

TWO MAN ROCK
	THREE MAN ROCK
	FOUR MAN ROCK
	FIVE MAN ROCK

**PLAN & PROFILE
CULVERT ROCKERY**
DOUGLAS-BAILER HILL RD IMPROVEMENTS
SAN JUAN COUNTY PUBLIC WORKS

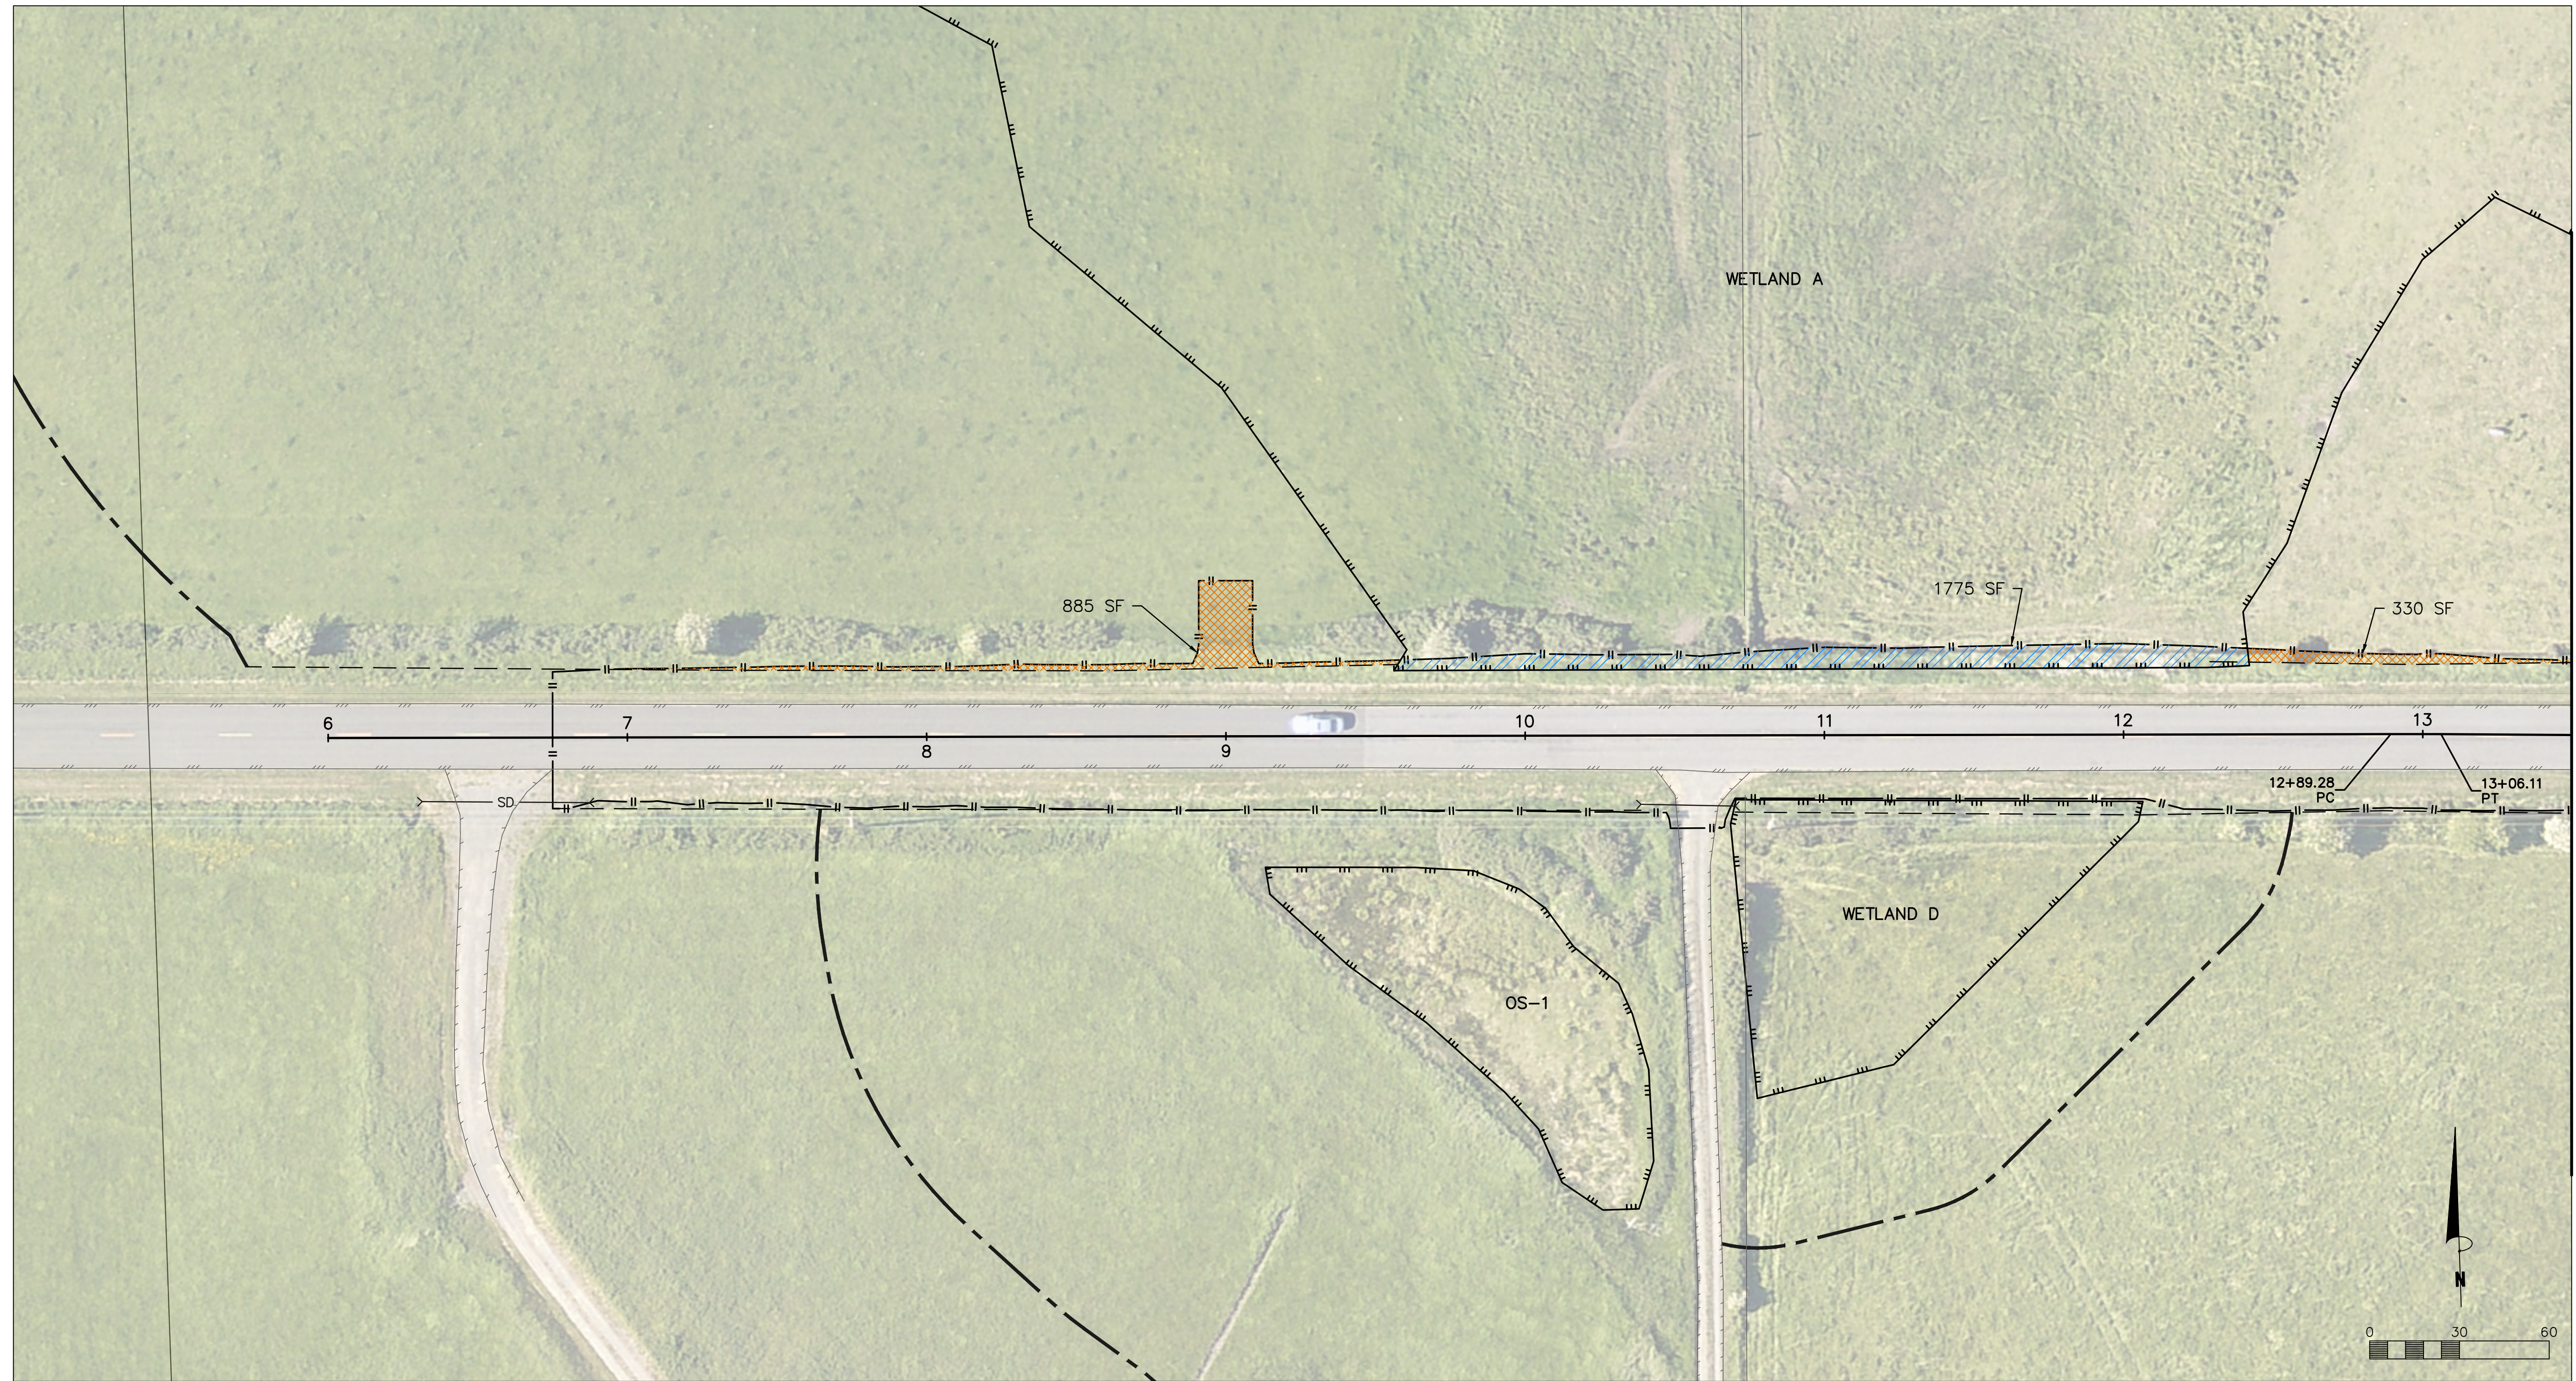
Figure 16. Impact Map (West)

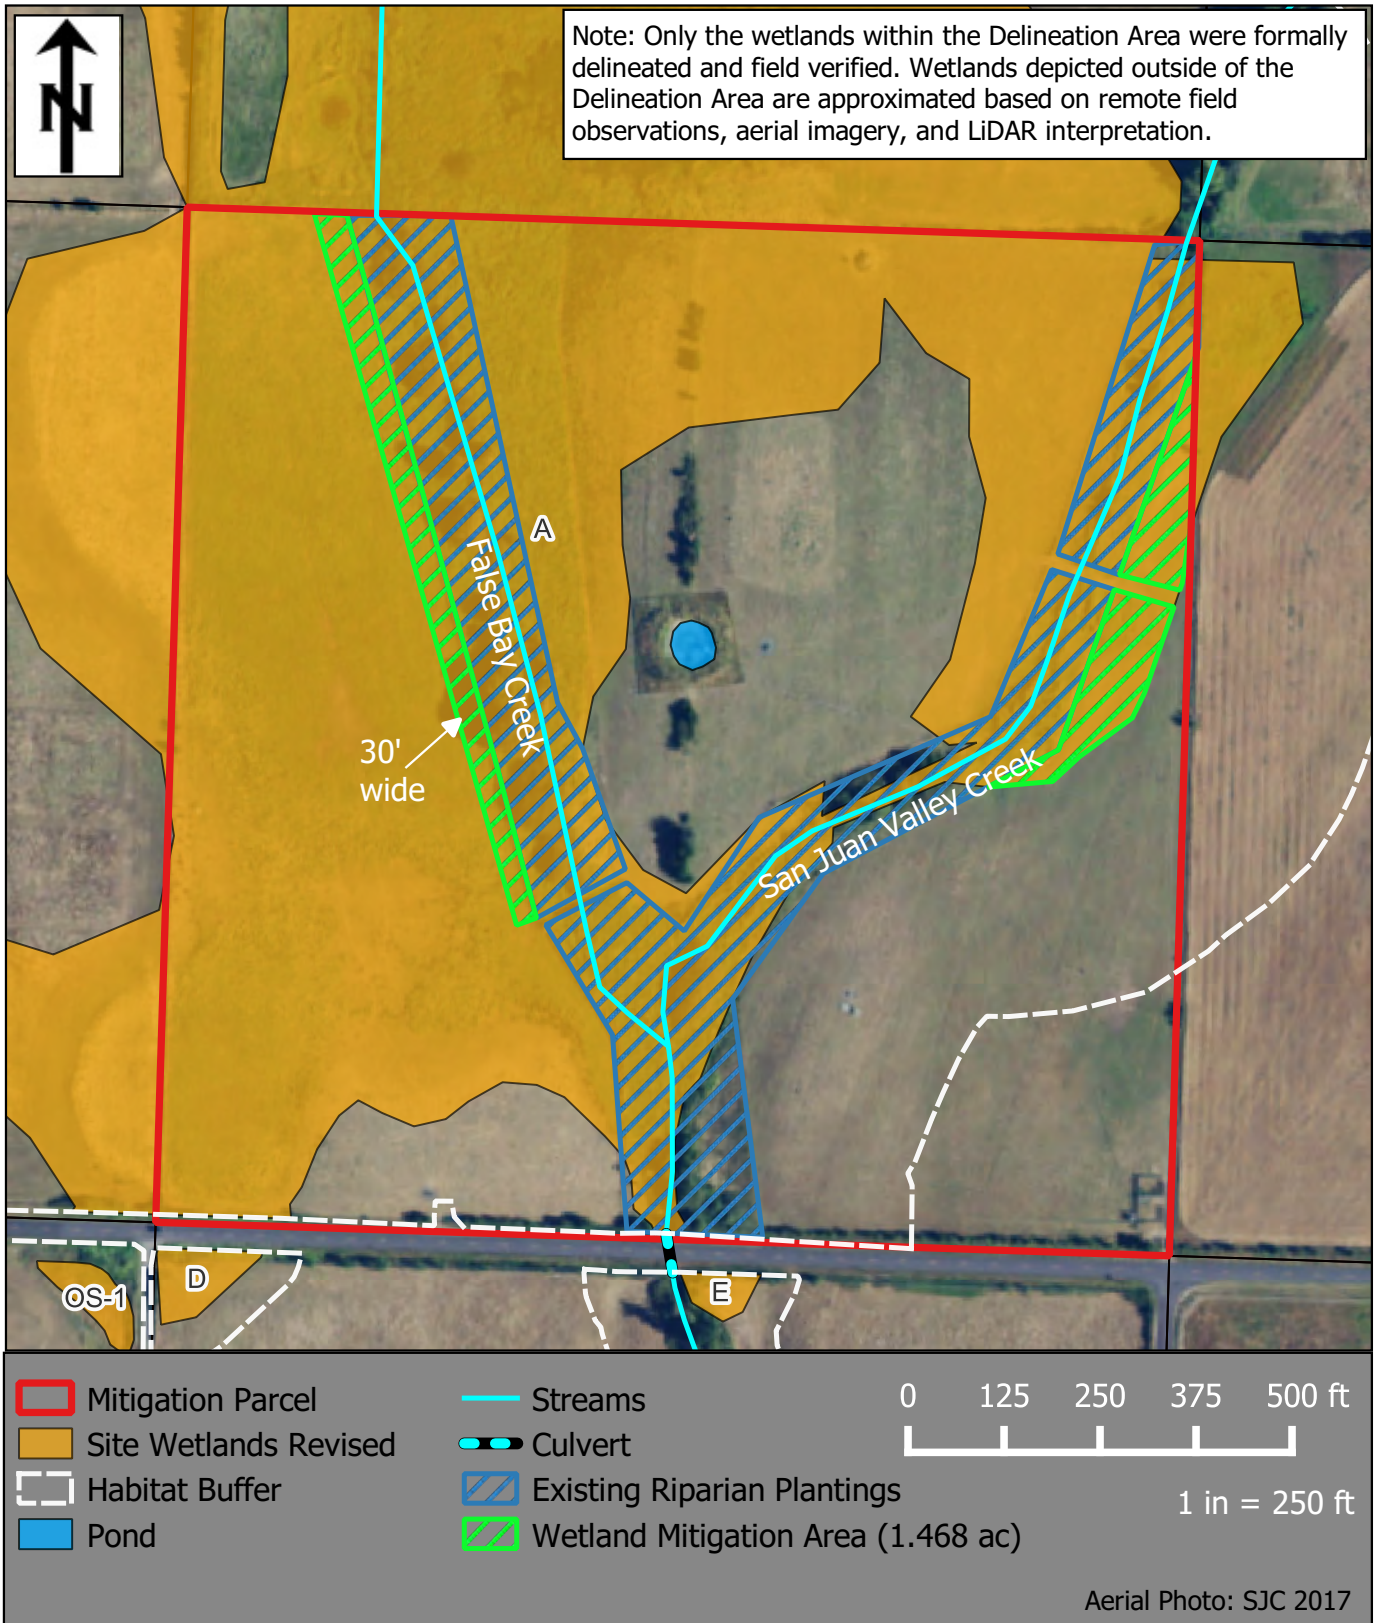
E COLOGICAL NORTHWEST  	Mitigation Map	Figure 19
	Bailer Hill/Douglas Road Road Improvements Project Critical Areas Assessment & Mitigation Plan	July 2024

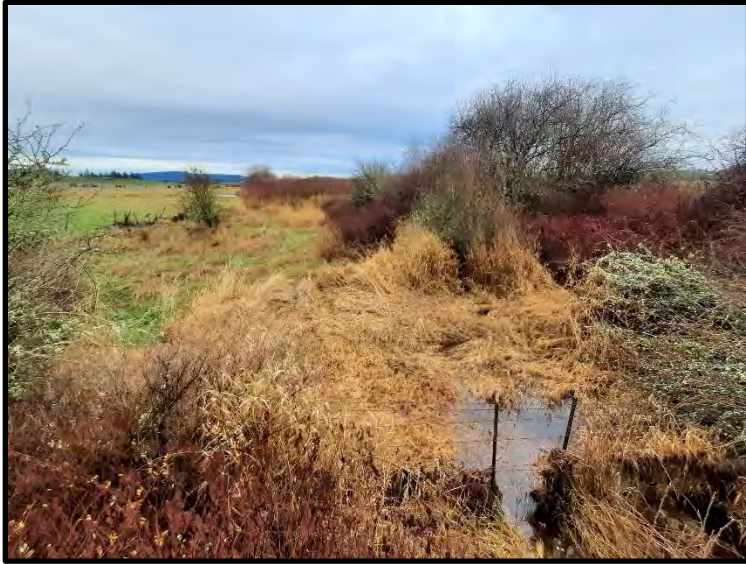
False Bay Creek and Wetland A – facing north from Bailer Hill Road.

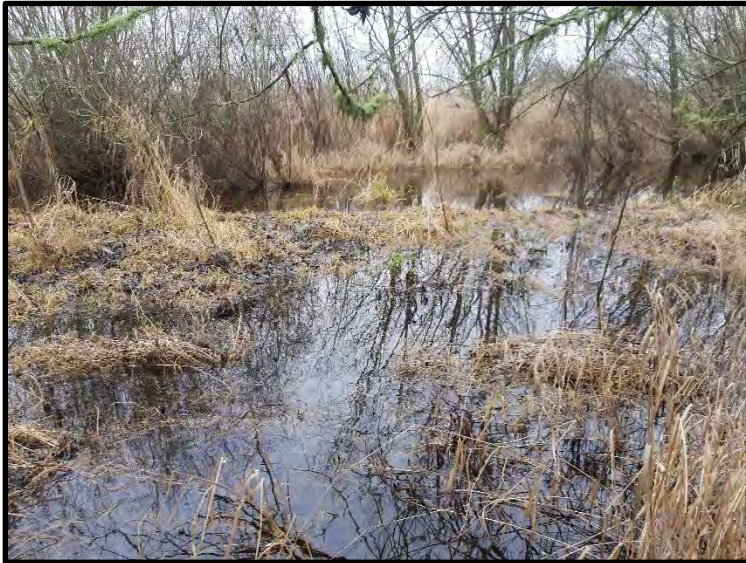
Wetland A - flooded by False Bay Creek.

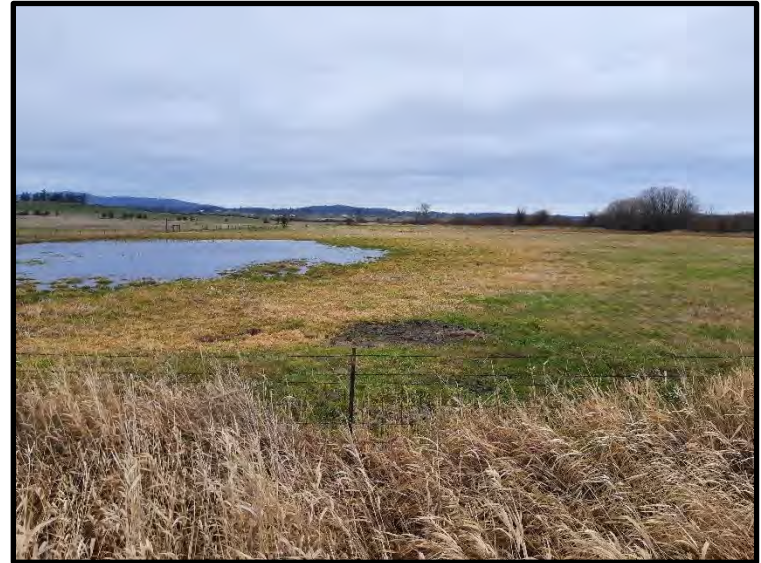
Wetland A – seasonal ponding in pasture

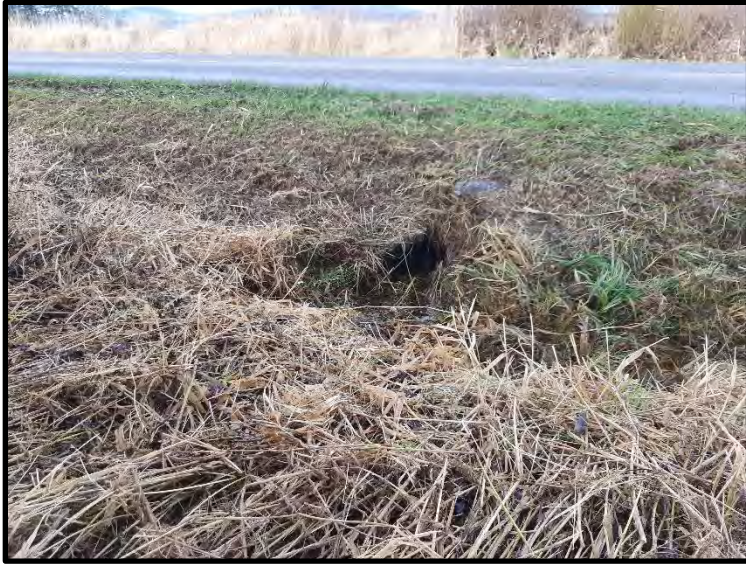
Wetland B – within roadside ROW south of Bailer Hill Road

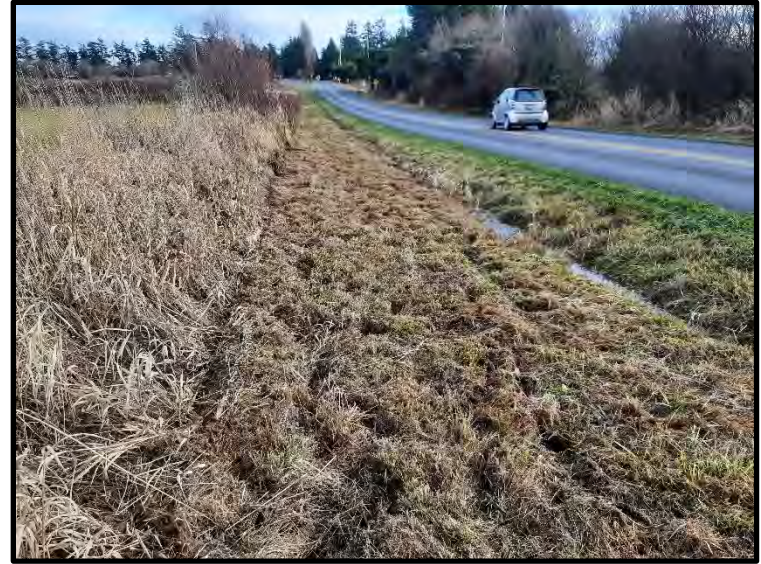
Wetland B – within roadside ROW north of Bailer Hill Road

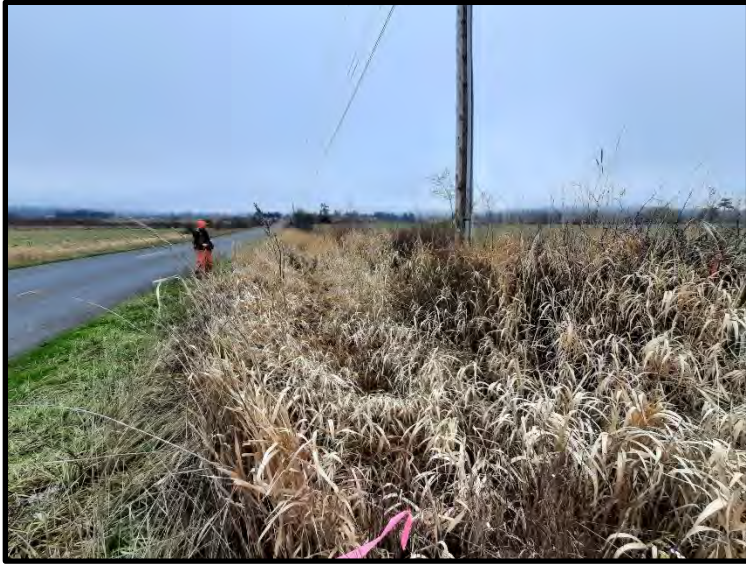
Wetland D – within roadside ROW south of Bailer Hill Road

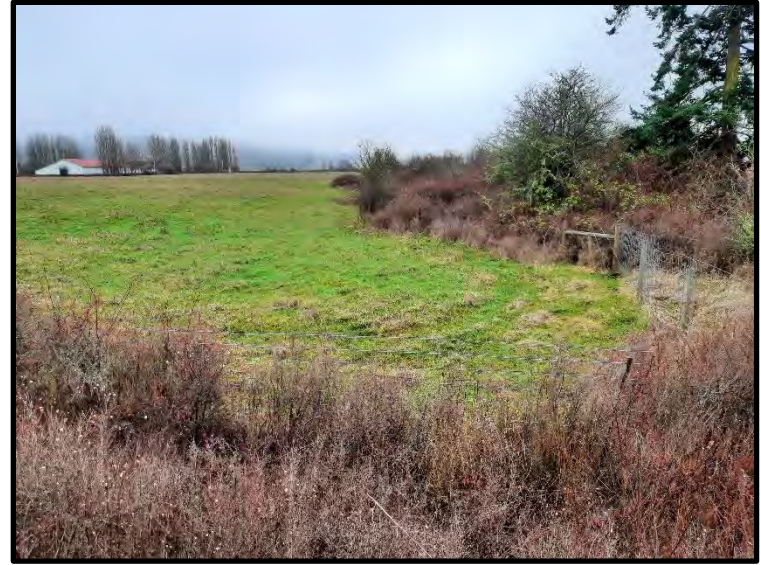
Wetland E – from Bailer Hill Road facing south
