CRITICAL AREAS ASSESSMENT & MITIGATION PLAN

(WETLAND DELINEATION & FWHCA ASSESSMENT)

BAILER HILL / DOUGLAS ROAD
ROAD IMPROVEMENTS PROJECT
SAN JUAN ISLAND, WA

JULY 2024

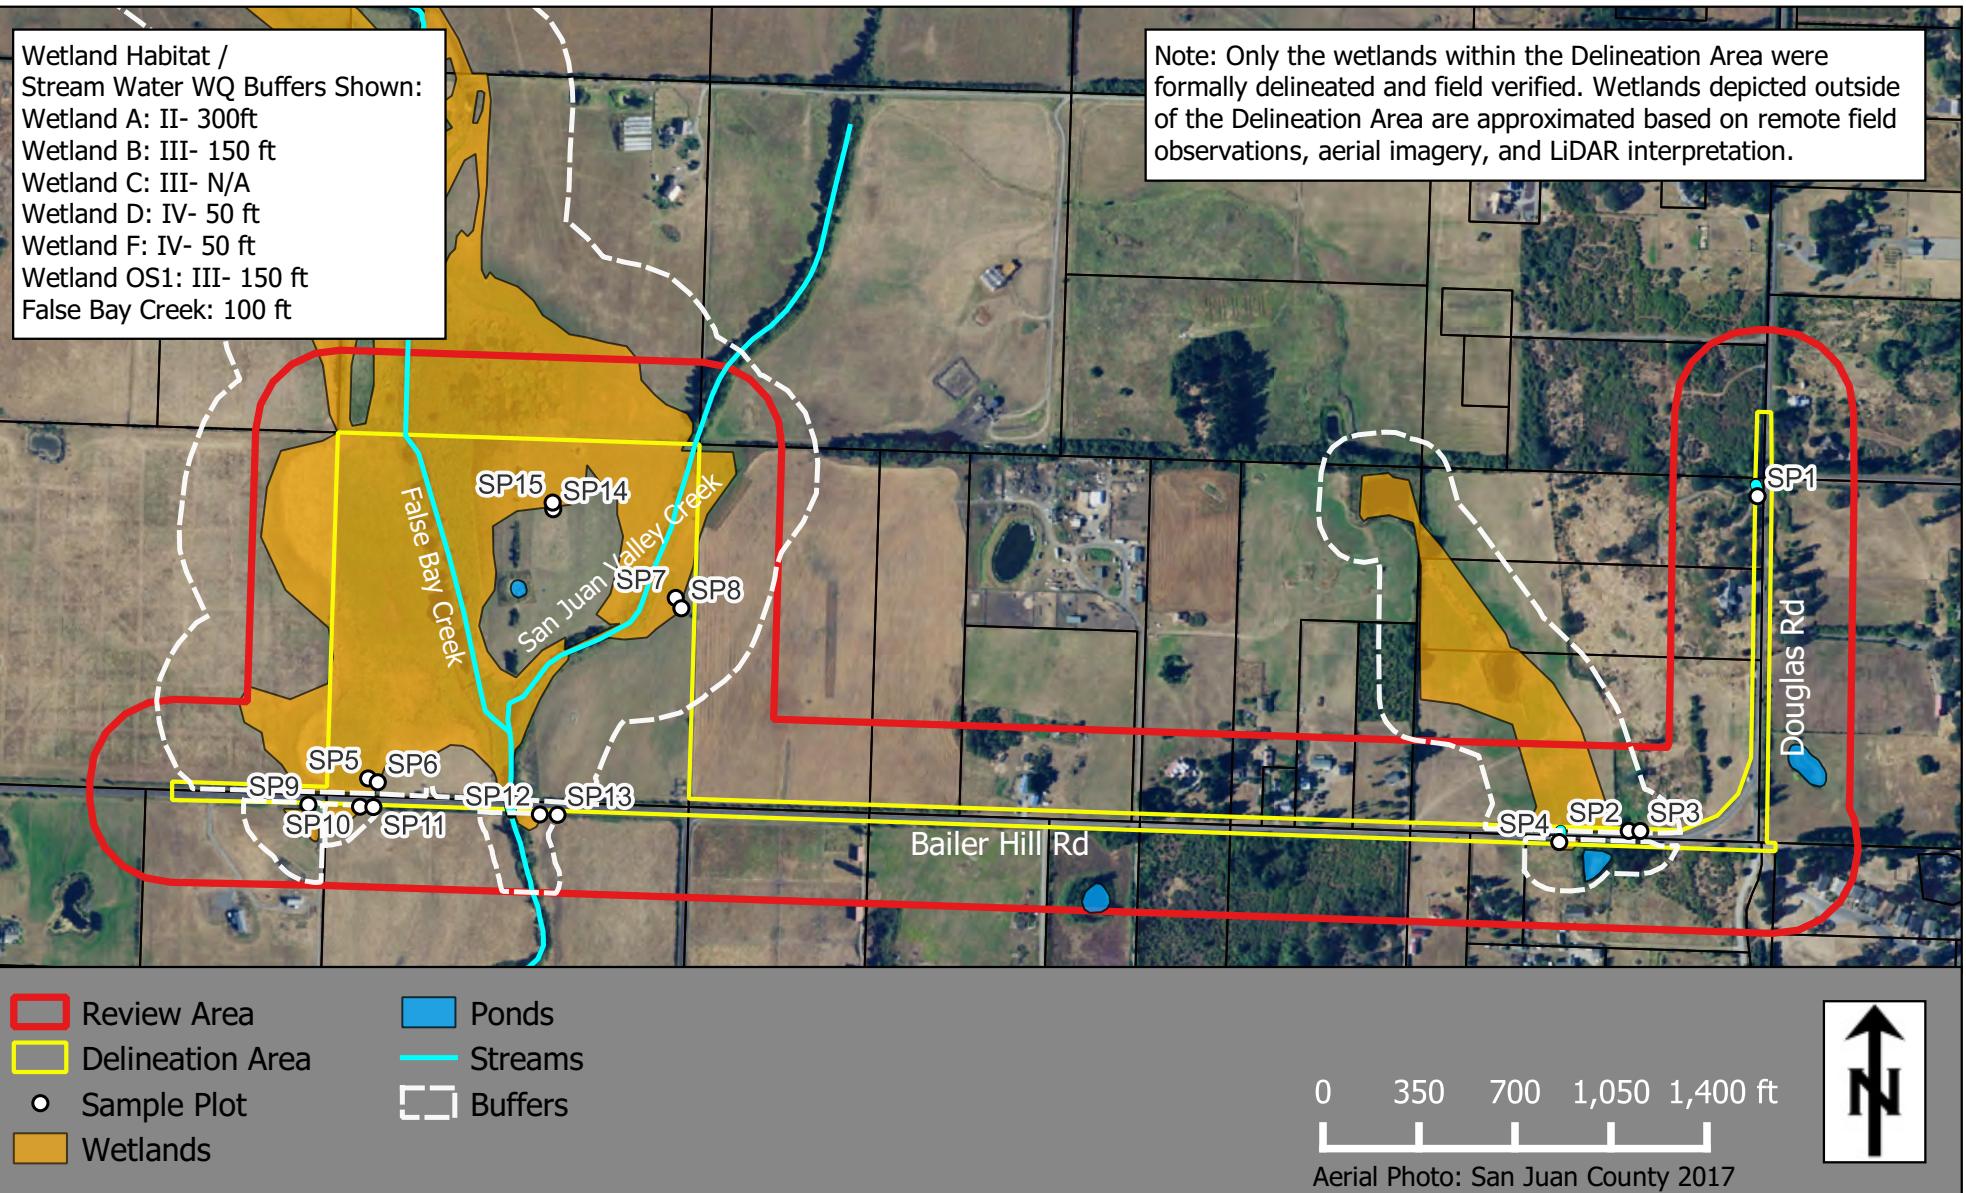
NES identified six wetlands, Wetlands A, B, C, D, E, and OS-1, within the review area (Figures 3-7). Wetland boundaries were only delineated within the ROW and subject parcel. Wetland OS-1 does not extend into the ROW but is located within 300 feet. The approximate location of the delineated wetlands and estimated extent of the off-site wetlands is shown in Figures 3-7. NES documented wetland conditions at Sample Plots (SP) 1, 2, 4, 5, 7, 10, 12, and 15 (Figures 3-7). Data sheets from the delineations are included in Appendix D of this report. The identified wetlands are summarized in Table 1 and are described below.

**Wetland Map
(Overview)**

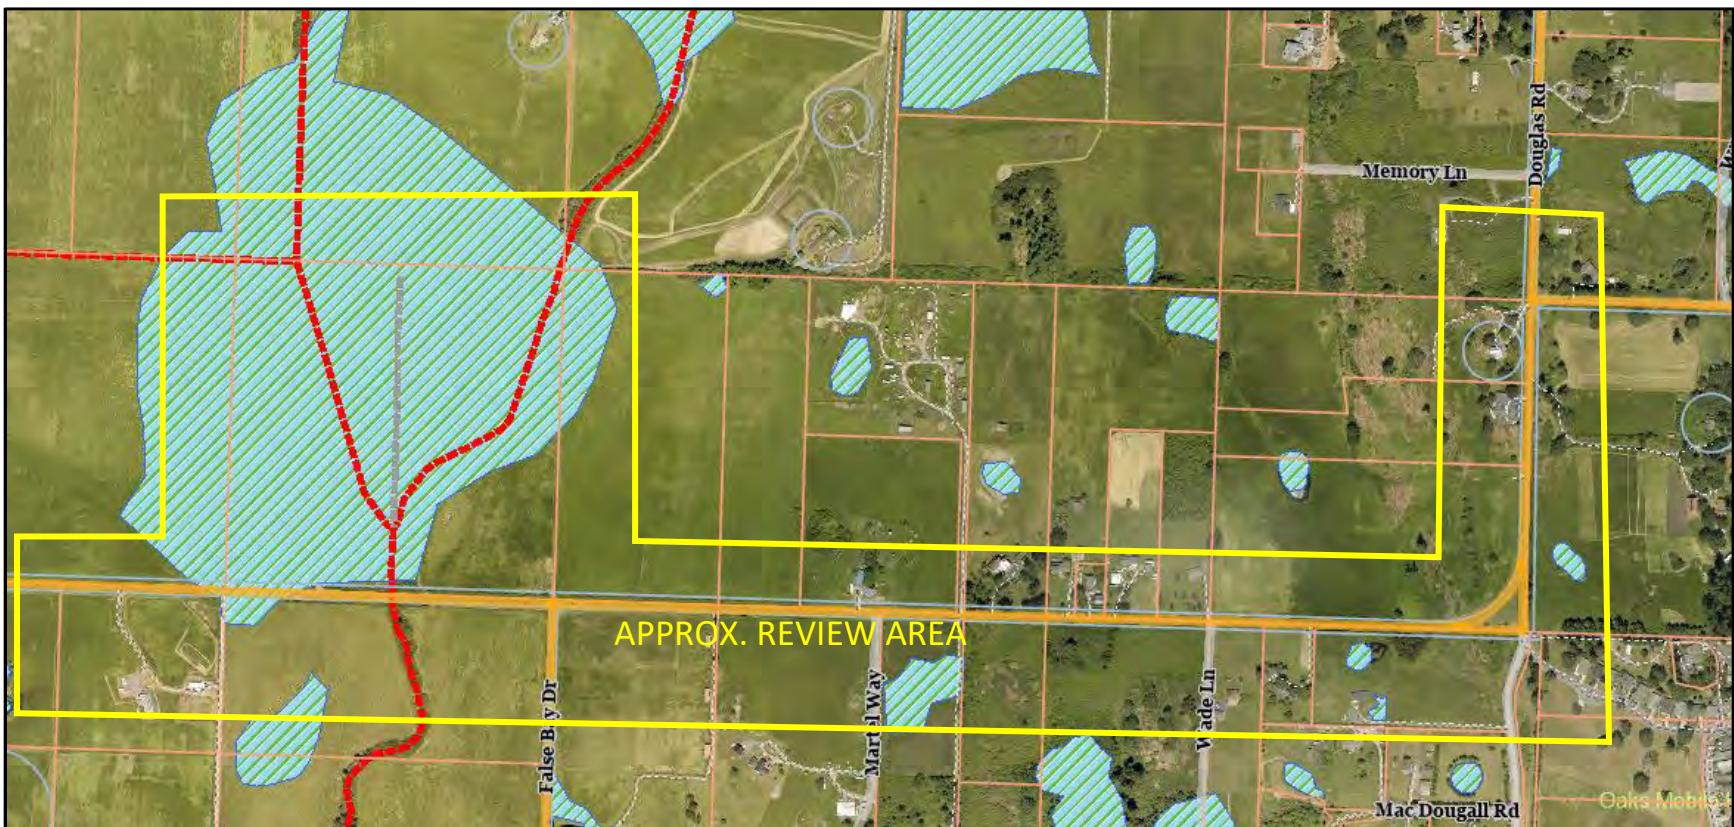
Figure 10

- **San Juan County Polaris- Possible Wetlands Map (San Juan County, 2024) (Figure 10)**
Possible wetlands are mapped by the County within the review area and vicinity.
Several of these were found to be ponds during the site investigation.

Polaris Critical Areas Map
(San Juan County, 2024)

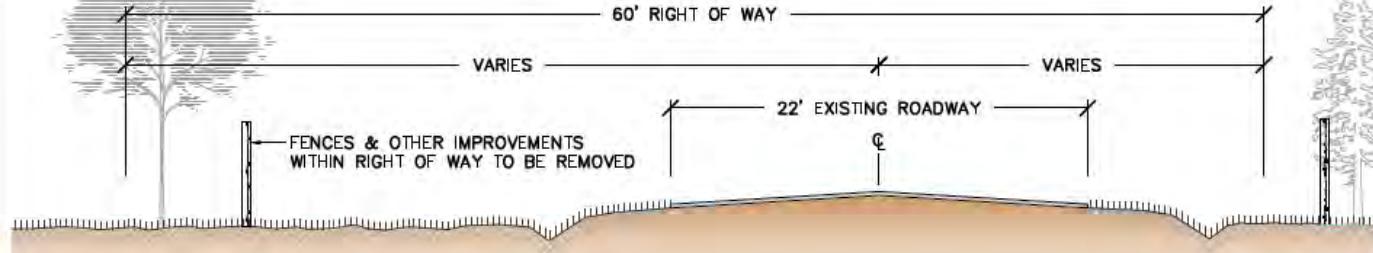
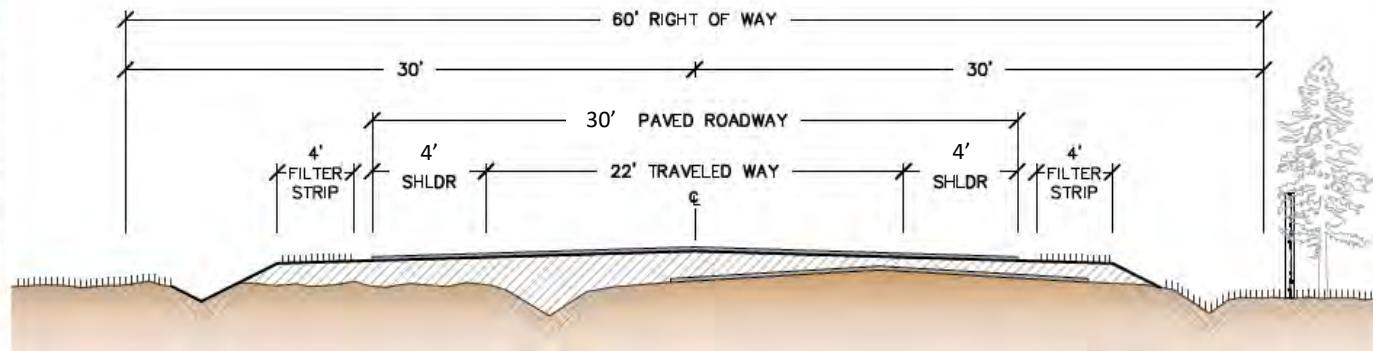
Figure 14

CURRENT CONDITIONS

DOUGLAS ROAD/BAILER HILL ROAD

PROPOSED ROADWAY SECTION

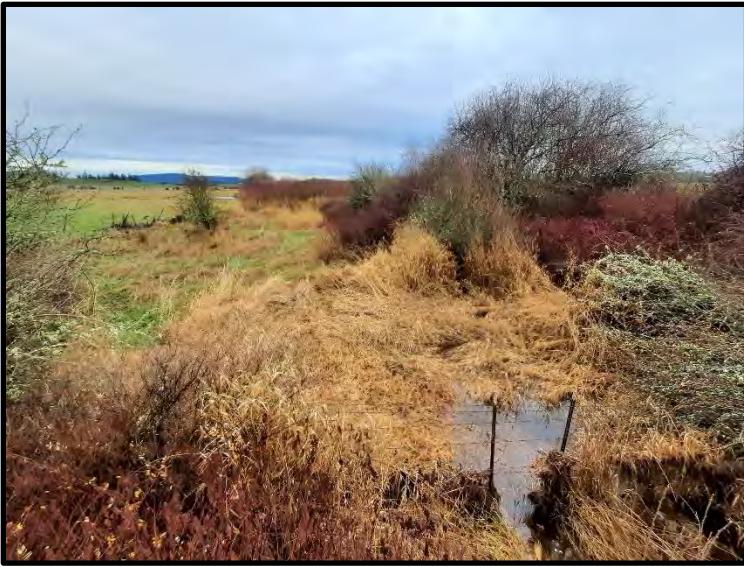
During the site assessment, areas of shallow seasonal ponding (approximately 6 inches) were observed in the wetland pasture and flooded areas adjacent to False Bay creek had approximately 14 inches of surface water. The remainder of the on-site wetland had saturated soils and high groundwater in the upper 12 inches of the soil profile. Wetland A appears to receive hydrology from overbank flooding from the streams, seasonally high and/or perched groundwater, surface runoff, and direct precipitation. Surface water outlets Wetland A at the southern extent via False Bay Creek through a culvert under Bailer Hill Road. Portions of Wetland A in the northeastern part of the parcel appear to have been drained and no longer meet wetland hydrology criteria, though hydric soils persist (see Section 3.3 for further detail). Drains are evident in LiDAR, but none were located on site.

False Bay Creek and Wetland A – facing north from Bailer Hill Road.

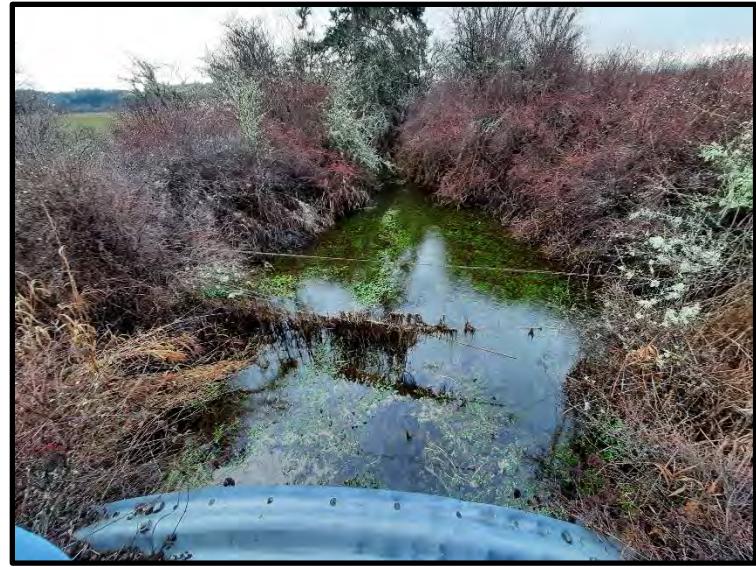
False Bay Creek – facing south from Bailer Hill Road.

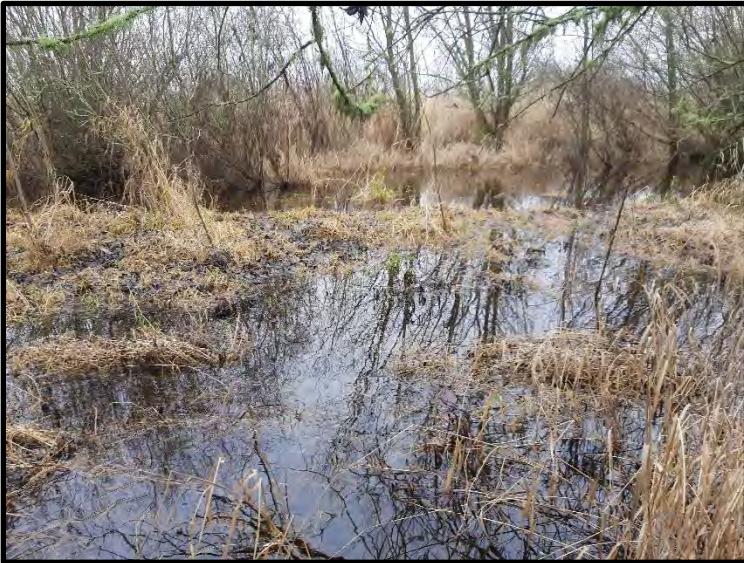
Wetland A - flooded by False Bay Creek.

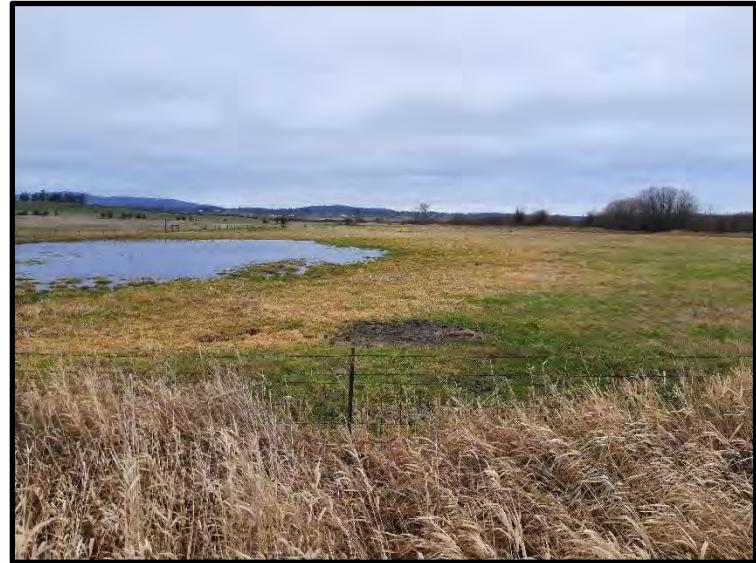
Wetland A – seasonal ponding in pasture

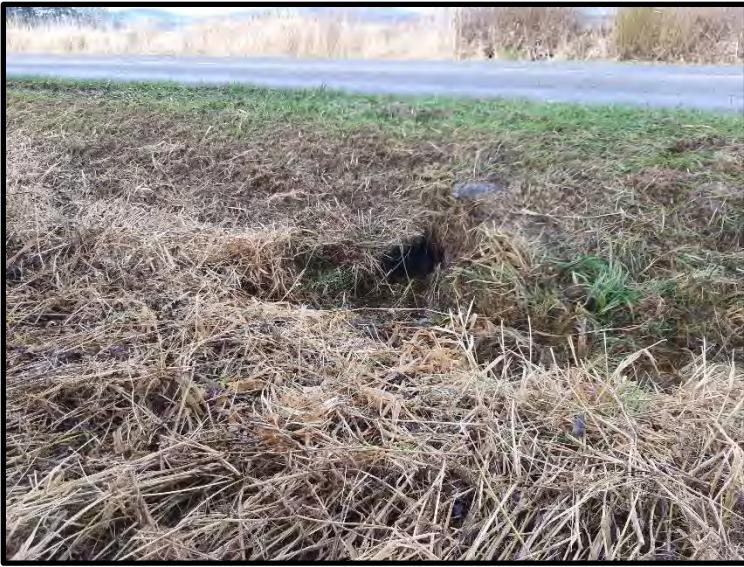
Shallow seasonal ponding was observed in Wetland B within the roadside ditch. Based on aerials, additional seasonal ponding within Wetland B occurs further down gradient outside of the review area. The excavated ponds contain permanent surface water ponding. Soil saturation and groundwater were observed in the upper part of the soil profile within Wetland B along Bailer Hill Road. Sources of hydrology to Wetland B appear to be seasonally high and/or perched groundwater, surface runoff, and direct precipitation.

Wetland B – within roadside ROW south of Baler Hill Road

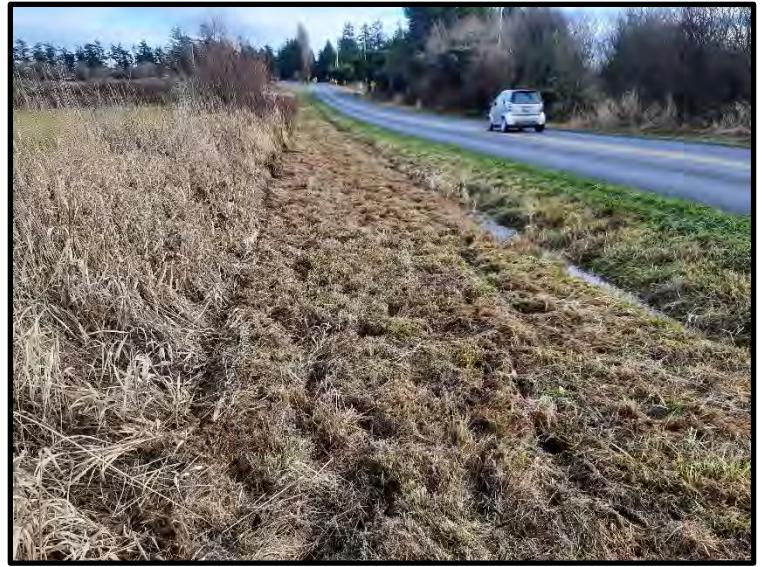
Wetland B – within roadside ROW north of Baler Hill Road

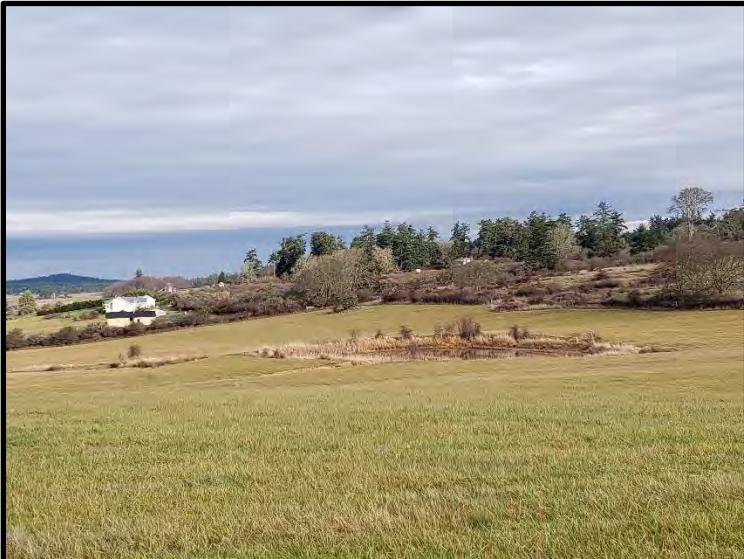
The majority of Wetland B is located outside of the review area and appears to be dominated by pasture grasses including reed canarygrass, red fescue, and velvet grass (*Holcus lanatus*). A small scrub-shrub vegetation component exists within Wetland B adjacent to the road, though it is not large enough to be considered second Cowardin vegetation class. Vegetation observed in this area includes English hawthorn (*Crataegus monogyna*), black hawthorn (*Crataegus douglasii*), Nootka rose, hardhack, red osier dogwood (*Cornus sericea*), Himalayan blackberry (*Rubus armeniacus*), slough sedge (*Carex obnupta*), reed canarygrass, and stinging nettle (*Urtica dioica*).

Off-site extent of Wetland B – north of Baler Hill Road

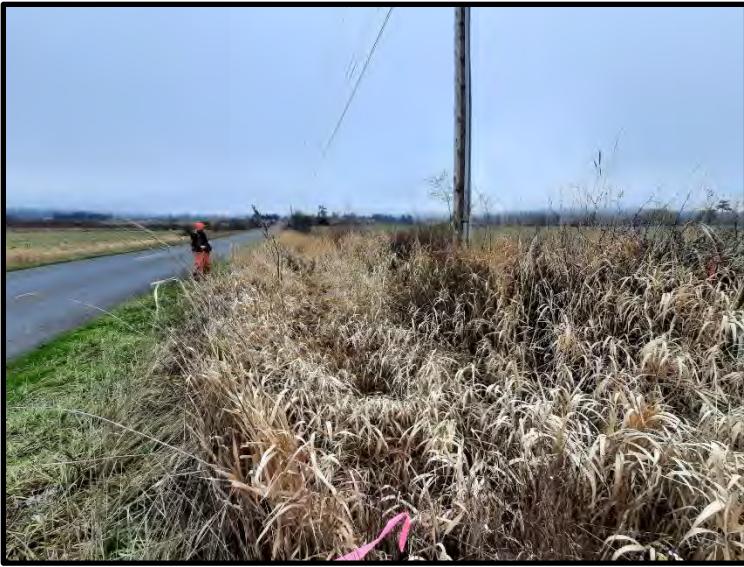
During the assessment, soils within Wetlands D and E were saturated and groundwater was observed within the upper part. The wetlands are situated on an approximately 2-3 percent gradient slope and have very little ponding. Wetland D has some seasonal ponding within the roadside ditch. Sources of hydrology likely include surface water runoff, seasonally high and/or perched groundwater, and direct precipitation. Wetland D slopes down to the roadside ditch, which flows east and outlets to False Bay Creek. Wetland E slopes down to the west, to the creek.

Wetland D – within roadside ROW south of Baler Hill Road

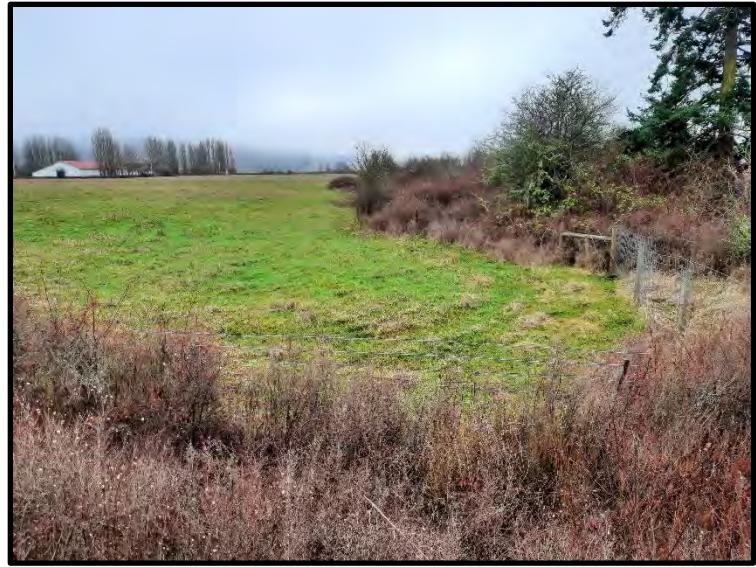
Wetland E – from Baler Hill Road facing south

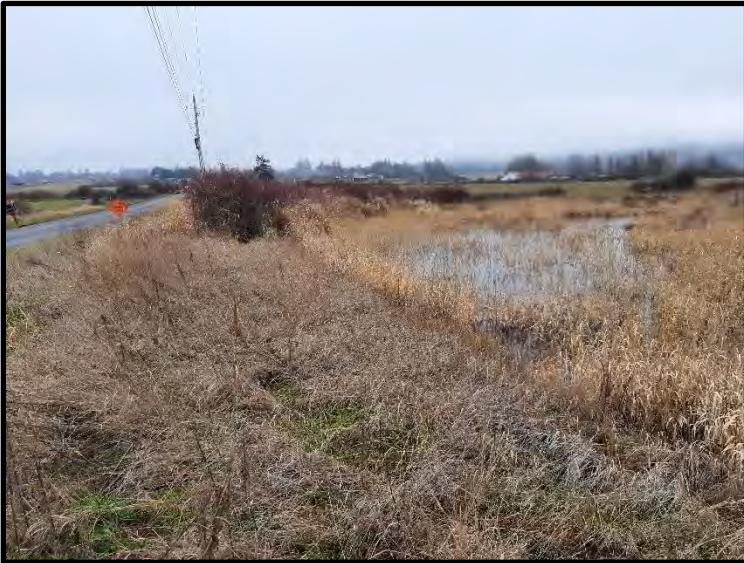
Wetland OS-1 is just outside of the southern ROW of Bailer Hill Road. The wetland appears to have been historically excavated and an earthen and quarry spall berm separates the wetland from the roadside ditch. Wetland OS-1 is a PEM depressional wetland dominated by reed canarygrass. Willow saplings, hardhack, and Nootka rose vegetate the berm and along the fringe of the wetland.

During the site assessment, Wetland OS-1 had approximately 20 inches of ponding. The majority of the wetland appears seasonally ponded and likely contains a narrow fringe of seasonally saturated soils. A pipe was observed just upgradient of the wetland that appears to discharge stormwater to the wetland. Additional sources of hydrology likely include surface water runoff, direct precipitation, and potentially seasonally high and/or perched groundwater. No surface water outlet was observed from Wetland OS-1.

Overview of Wetland OS-1

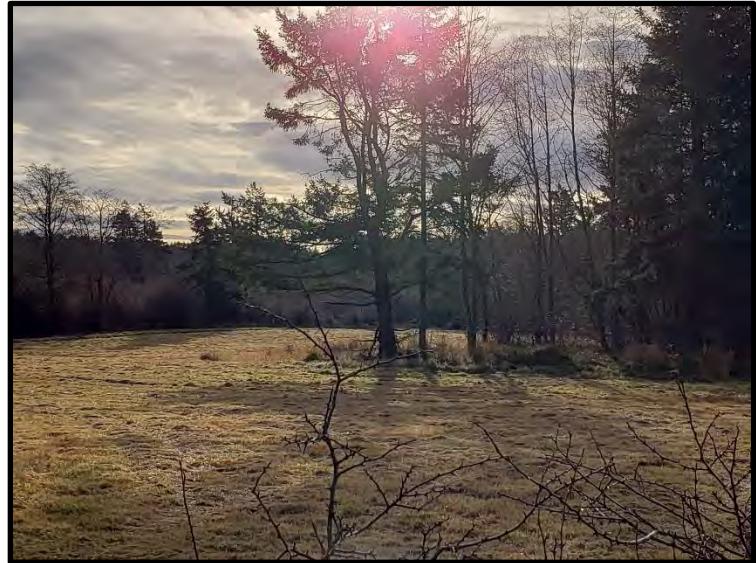
Off-site pond south of Baler Hill Rd

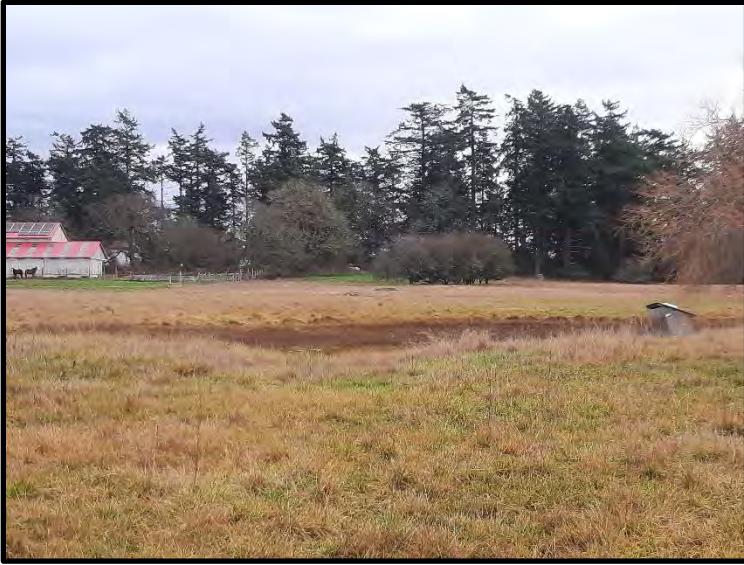
Off-site pond east of Douglas Road

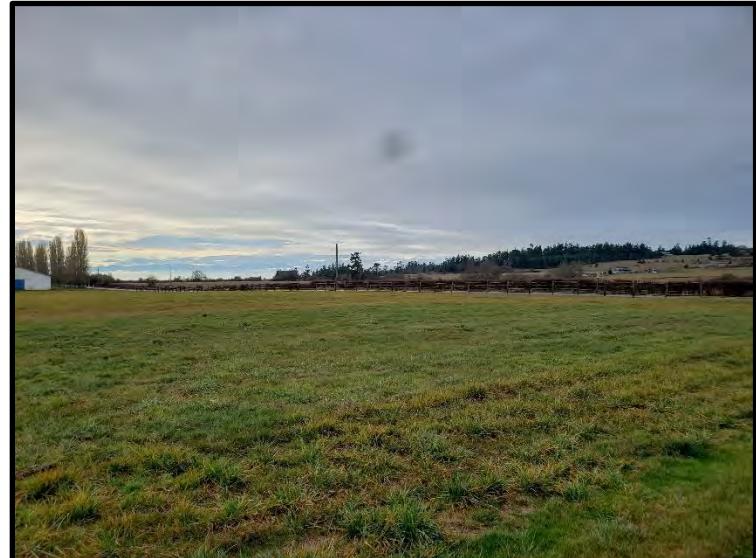
Uplands within the review area include non-wetland pasture, ROW, and residential areas. The uplands are generally composed of grass and weedy herbaceous species as well as some areas of dense shrubs. Herbaceous vegetation observed in the upland pastures and ROW includes orchard grass (*Dactylis glomerata*), sweet vernal grass (*Anthoxanthum odoratum*), reed canarygrass, red fescue, tall fescue, bluegrass (*Poa sp.*), bentgrass, crested dog's tail (*Cynosurus cristatus*), queen Anne's lace (*Daucus carota*), hairy cat's ear (*Hypochaeris radicata*), dock (*Rumex sp.*), geranium (*Geranium sp.*), clover (*Trifolium sp.*), creeping buttercup, and vetch (*Vicia sp.*). Shrub vegetation was dominated by English hawthorn, snowberry, and Nootka rose. Black hawthorn, red osier dogwood, and Himalayan blackberry were also observed.

Upland pasture within review area
