COFFELT FARM LEASE RATE AND RESERVE STUDY

Relevant to 150 acres of the 189-acre Coffelt Farm Preserve
1071 Crow Valley Road
Eastsound, WA 98245
FCS File Number: 2021-036 REV

October 19, 2021

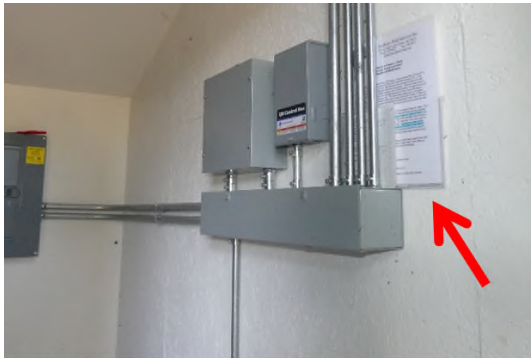
There is water treatment/chlorination system in this pump house which typically requires periodic maintenance including plumbing components. There is a shut-off valve in this building for the Dairy barn and possibly for the farm manager's residence as well.

Document with well maintenance info

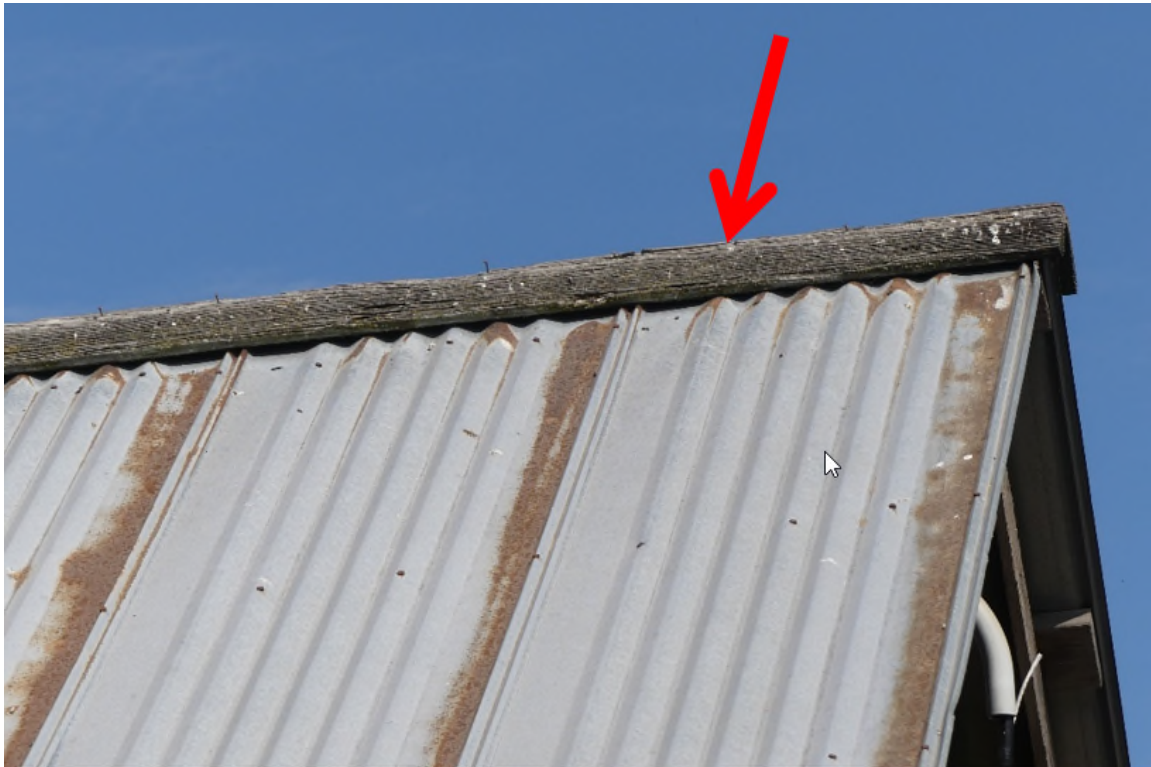
No structural deficiencies were observed. The wood columns appear to be creosoted timbers which should be resistant to decay. The building is in generally good condition, typical of smaller barns of this age.

Wood ridge cap

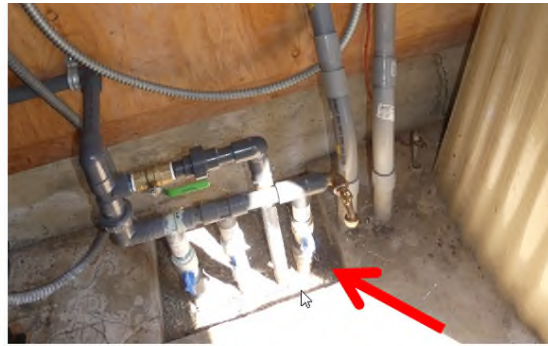
shut-off valves
